Failure Mechanism Identification of Hook Components in Automatic Machines Using Visual and Material Analysis

Nabila Desy Rahmawati^{1*} and Lutiyatmi²

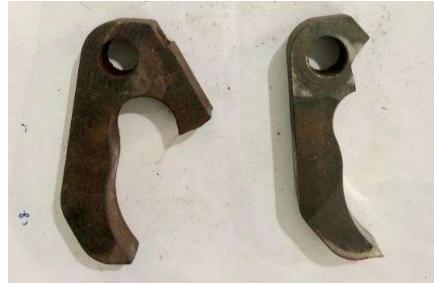
Figure 3. Sample hook.

Two fractured hooks, designated as Sample A and Sample B (shown in Figure 3), were analyzed. Based on earlier fractographic studies, the nature of fracture (ductile, brittle, or fatigue) can be determined by analyzing fracture surface morphology in top and side views, where features such as dimples, striations, and cleavage facets serve as key indicators [12]. The examination included observing the fracture surface, top view, and side view of the component, which can indicate whether the failure is brittle, ductile, or due to cyclic loading (fatigue).

Based on visual inspection of both samples, both Sample A and Sample B exhibit typical characteristics of brittle fracture. The fracture surface appears relatively flat and perpendicular to the loading direction, with a granular texture and no signs of plastic deformation around the fracture area. No beach marks or gradual crack growth patterns typically seen in fatigue fractures were observed. These characteristics indicate that failure in both samples occurred suddenly due to momentary tensile or flexural stresses exceeding the material's strength, causing the crack to propagate rapidly without warning. Such fracture characteristics are consistent with cleavage-dominated brittle fracture commonly observed in hardened steels subjected to impact or shock loading [13], [14].

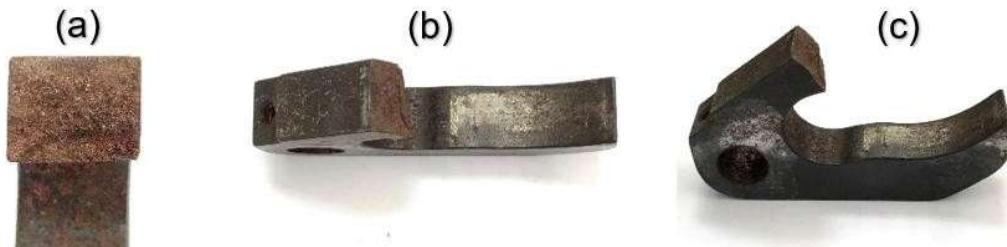
Figure 4. Sample A, (a) fracture surface detail, (b) top view, and (c) side view.

Visual observation of Sample A (shown in Figure 4) revealed a flat, granular fracture surface parallel to the cross-sectional plane of the material, with no necking or signs of plastic deformation around the fracture area. The fine-grained surface texture and the absence of beach marks indicate that the crack propagated rapidly and uniformly through the metal's crystal planes, without gradual crack growth.

The top view shows that the fracture surface is flat and parallel to the cross-sectional axis, with no signs of bending or stretching of the metal fibers at the fracture edge. The fracture line is also distinct and relatively straight, indicating that crack propagation occurred rapidly through the crystal planes, rather than through gradual growth. Similarly, the side view shows that the fractured portion has a flat surface and a sharp fracture angle.

To improve component durability, it is recommended to apply surface hardening (such as flame hardening) followed by light tempering to balance hardness and ductility. Additionally, shot peening should be introduced to generate compressive residual stress, delaying crack initiation. Regular non-destructive inspections and alignment checks are essential to prevent impact-induced failures.

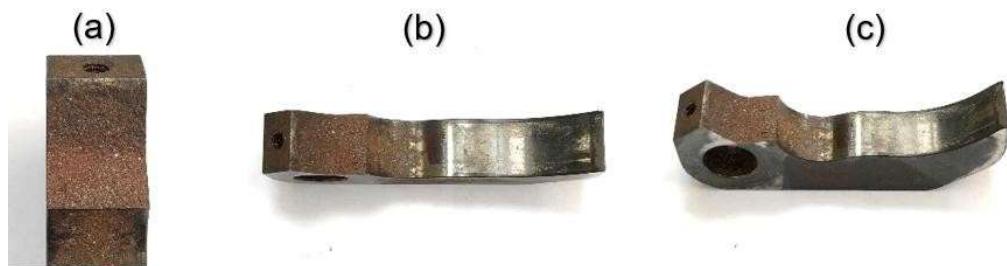
Figure 5. Sample B, (a) fracture surface detail, (b) top view, and (c) side view.

Visual observation of Sample B (shown in Figure 5) revealed a flat, granular fracture surface that appeared perpendicular to the direction of the force. There were no signs of plastic deformation such as necking or stretching of the material around the fracture area, indicating that the failure process occurred suddenly and without warning. The rough, shiny, irregular granular surface indicates that the crack propagated rapidly

through the metal's crystal planes, indicating a cleavage fracture mechanism common in materials with low ductility or in brittle conditions due to thermal treatment or shock loading. Furthermore, the position of the threaded hole at the top could potentially be a stress concentration point that triggered crack initiation.

The top view shows that the fractured portion did not experience significant bending or displacement. The metal surface around the fracture area shows a sharp transition between the intact and fractured portions, with no signs of necking or plastic stretching. The slightly shiny metal surface on some sides indicates minor friction between the surfaces during the rapid cracking process. Similarly, from the side view, the fracture surface contours appear flat and parallel, exhibiting no curved or stepped patterns. The geometry is also intact and shows no significant plastic deformation around the fracture edges.
