Analysis of tree quality on the green line using google earth in Tanjung Morawa District, Deli Serdang Regency

Samsuri¹, Esterlina Napitupulu¹, Alfian Gunawan Ahmad¹, Anita Zaitunah^{*1}

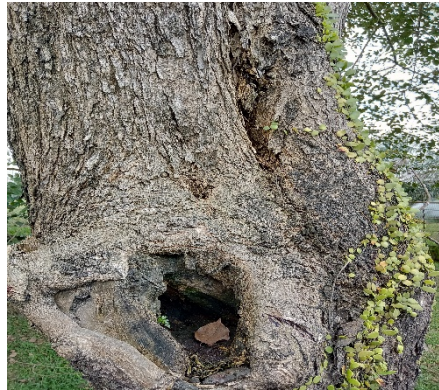
Tree damage caused by pests and diseases in the form of ants, termites, fungi, caterpillars and insects. Termites usually attack the roots and base of the main stem by eating and making holes as nests for breeding. This causes the tree trunk to become weathered and easily fall (rowong) (Figure 4). As for actions to reduce the impact of pest and disease attacks by cutting the affected parts of the tree.

Figure 4. A hole at mahogany (*Swetenia mahogani*)

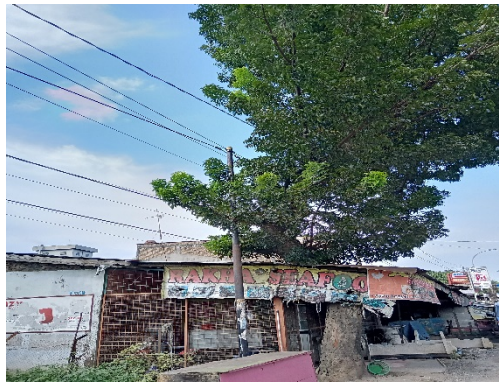
Tilts and alignments are very prone to collapse and disrupt cable and telephone networks. In (Figure 6) mahogany trunks and headers have penetrated the roof/tile of people's houses. The slope of mahogany trees has also reached $\leq 60^\circ$ towards cable and electricity networks or collapsed trees that will disturb residents. This tree must be cut down immediately to avoid falling trees on people's homes which will cause damage to buildings or threaten lives. And provide counseling for residents around trees with symptoms of collapse not to erect buildings around trees with a slope of $\leq 60^\circ$ and heavy headers.

Figure 6. Mahogany trees (*Swietenia mahagoni*) pose a threat to the home and cables

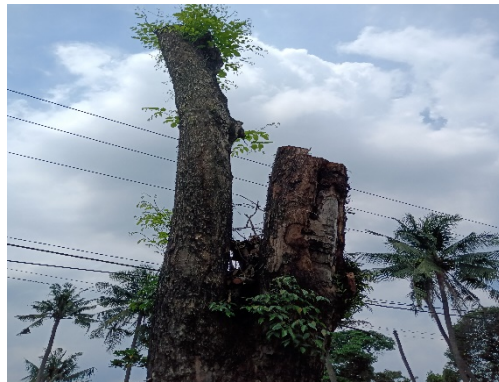
Direct pruning by cutting branches from top to bottom directly and pruning scars are also not sprayed or smeared with disinfectants, so this makes the plant susceptible to pests and diseases that cause damage to all parts of the tree (Figure 7).

Figure 7. Red sandalwood (*Pterocarpus indicus*) which have been felled without further treatment
