Analysis of tree quality on the green line using google earth in Tanjung Morawa District, Deli Serdang Regency

Samsuri¹, Esterlina Napitupulu¹, Alfian Gunawan Ahmad¹, Anita Zaitunah^{*1}

¹Faculty of Forestry, Universitas Sumatera Utara, Kampus 2 Bekala, Deli Serdang, 20353, Indonesia

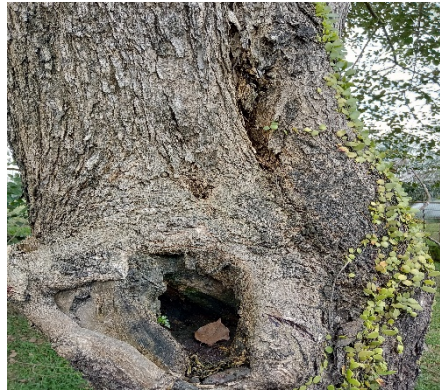
Tree damage caused by pests and diseases in the form of ants, termites, fungi, caterpillars and insects. Termites usually attack the roots and base of the main stem by eating and making holes as nests for breeding. This causes the tree trunk to become weathered and easily fall (rowong) (Figure 4). As for actions to reduce the impact of pest and disease attacks by cutting the affected parts of the tree.

Figure 4. A hole at mahogany (*Swetenia mahogani*)

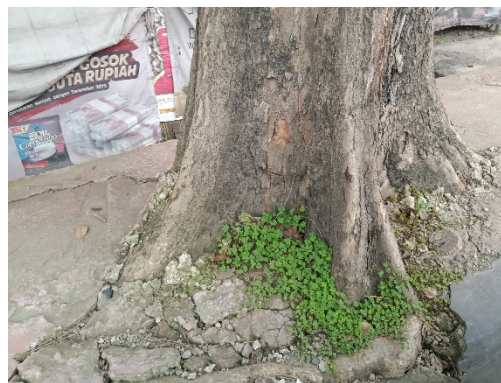
The root system of mahogany, angsana, glodokan and other trees planted on the roadside is taproot, so many roots propagate into roads, sidewalks or drainage around trees. Mahogany roots have damaged the road, because the pavement has been damaged and the ground is bumpy (Figure 5) so that the tree can breathe. One of the factors that cause tree roots to damage the sidewalk is the narrowness of the soil where the tree grows. Open ground for tree growth is mostly only 10 cm from the tree trunk. This is in accordance with [10] which states that trees need space to grow so that tree growth does not stop and tree roots do not come out of the ground.

Figure 5. Rooting of mahogany (*Swetenia mahogani*) yang merusak trotoar

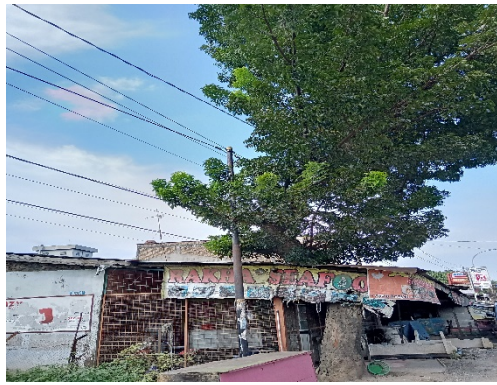
Tilts and alignments are very prone to collapse and disrupt cable and telephone networks. In (Figure 6) mahogany trunks and headers have penetrated the roof/tile of people's houses. The slope of mahogany trees has also reached $\leq 60^\circ$ towards cable and electricity networks or collapsed trees that will disturb residents. This tree must be cut down immediately to avoid falling trees on people's homes which will cause damage to buildings or threaten lives. And provide counseling for residents around trees with symptoms of collapse not to erect buildings around trees with a slope of $\leq 60^\circ$ and heavy headers.

Figure 6. Mahogany trees (*Swietenia mahagoni*) pose a threat to the home and cables

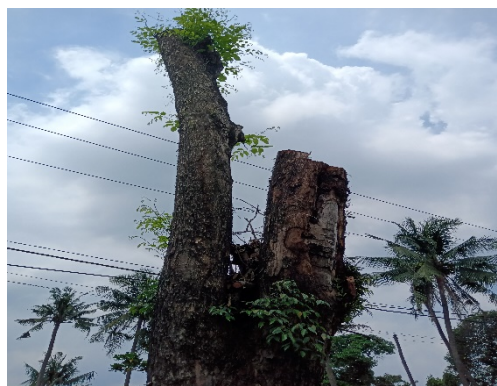
Direct pruning by cutting branches from top to bottom directly and pruning scars are also not sprayed or smeared with disinfectants, so this makes the plant susceptible to pests and diseases that cause damage to all parts of the tree (Figure 7).

Figure 7. Red sandalwood (*Pterocarpus indicus*) which have been felled without further treatment
