Study of Pedestrian Path Comfort Evaluation in Campus Environment of Institut Teknologi Sumatera

¹Department of Architecture, Faculty of Infrastructure Technology and Regional, Institut Teknologi Sumatera, Lampung Selatan, 35365, Indonesia.

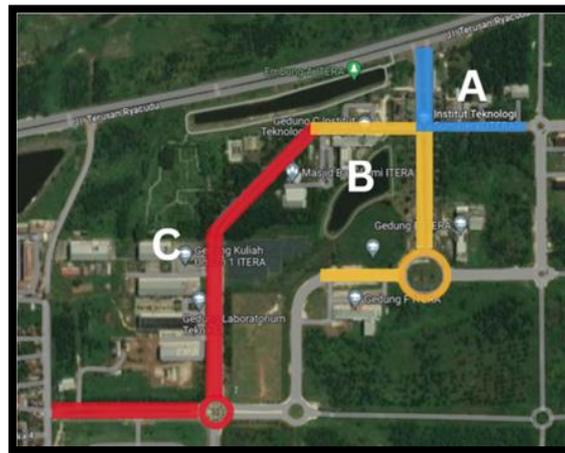
Figure 2 Pedestrian path zone map

I Institut Teknologi Sumatera campus is equipped with pedestrian pathways that facilitate the integration of various campus activities. Consequently, specific areas within the campus have been selected for comprehensive analysis. Figure 2 offers a visual representation of these zones. This study encompasses three distinct areas: Zone A encompasses the main gate, Building A, Building B, the gallery, the BKL canteen, and the dormitory. Zone B includes Buildings C and D, the road intersection, Building E, the public lecture hall 2, the road roundabout, and Building F. Zone C comprises the basketball court, the RK canteen, the public lecture hall 1, the Engineering Laboratory 2, the Engineering Laboratory 5, the OZT laboratory, the road roundabout, and the west gate.

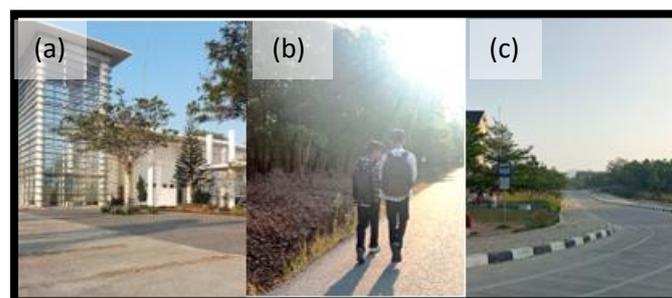
As illustrated in Figure 3, the pedestrian pathways in Zone A remain disparate and disorganized. Figure 4(a), illustrates that the walkway surrounding the main entrance is constructed with concrete, a material that is both practical and conducive to pedestrian traffic. Furthermore, the pedestrian path surrounding the main entrance is unobstructed, functioning not only as the primary thoroughfare for pedestrians but also as a gathering point for students. Furthermore, as illustrated in Figure 3(b), the absence of a designated pedestrian path on campus forces pedestrians to traverse the main road shoulder, which is also utilized by motorized vehicles. Consequently, pedestrians are compelled to utilize the highway to reach their intended destination. Figure 4(c), illustrates that the pathway situated in front of the dormitory is commendable, as it is furnished with a sidewalk constructed of paving blocks. However, the absence of vegetation surrounding the sidewalk gives rise to the sensation of heat when traversing it.

Figure 3 (a) Pedestrian path near the campus entrance (b) Pedestrian path to the BKL cafeteria (c) Pedestrian path in the dormitory area

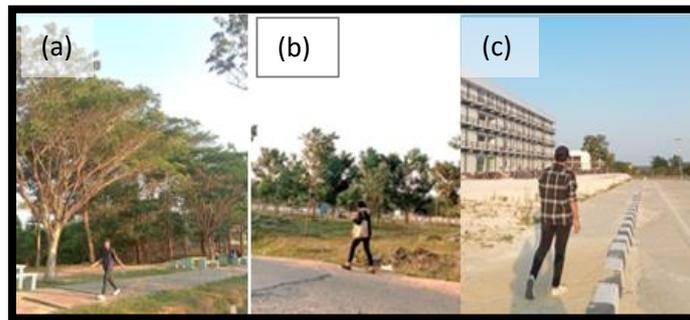
As illustrated in Figure 4(a), the pedestrian path in Zone B is observed to be in a satisfactory condition, offering a relatively comfortable and unobstructed passage. The materials utilized in the construction of the pedestrian path within this zone are concrete and paving blocks. However, the concrete surface of the pedestrian path is in poor condition due to its rough texture, which causes significant friction when walking. This area also features supporting vegetation and seating areas along the pedestrian path, providing additional temporary resting points. In zone B, as illustrated in Figure 4(b), there is no designated pedestrian path, and thus pedestrians utilize the highway as a walking area. Figure 4(c) depicts the condition of the pedestrian path that has been equipped with sidewalk facilities.

Figure 4 (a) Pedestrian path in building area E (b) Pedestrian path in building area C (c) Pedestrian path in building area F

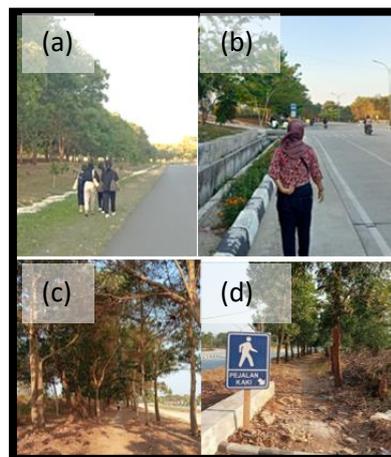
Figure 5(a) illustrates the conditions in zone C, which are less comfortable and less safe for pedestrians due to the absence of a sidewalk along the route connecting the C & D Building to the engineering laboratory building. This lack of infrastructure makes pedestrians feel unsafe, as they are at risk of being hit by motorized vehicles. Figure 5(b) illustrates the condition of the pedestrian path in the area in front of the OZT building, Engineering Laboratories 1 & 2, and GKU 1. The pedestrian path is constructed with paving material. Additionally, Figure 5(c) depicts a pedestrian path situated adjacent to the west gate of Zone C. This path is characterized by abundant vegetation, which provides a cooling effect when traversing it. Figure 5(d) illustrates a unique signage system designated for this pedestrian path. However, the path's condition is less than optimal, lacking a defined surface and proper maintenance. Consequently, during precipitation events, the lack of a paved surface and the presence of mud and slippery conditions pose a significant hazard to users.

Figure 5 (a) Pedestrian path to the engineering laboratory building (b) pedestrian path in front of the OZT laboratory building (c) pedestrian path at the west gate (d) pedestrian path conditions that do not yet have pavement material

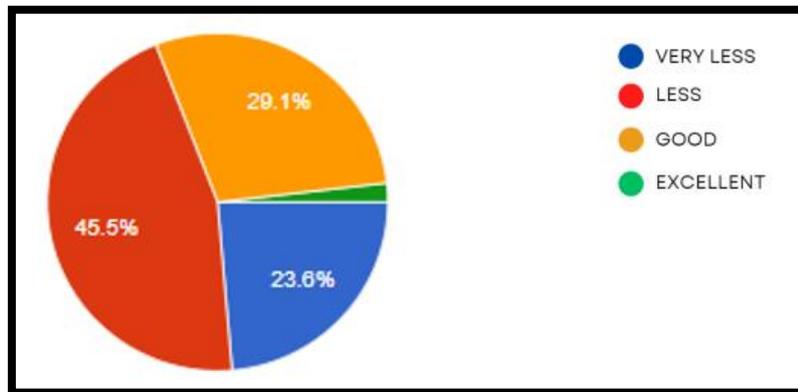
Figure 6 Diagram of respondents' assessment of the current condition of pedestrian paths

Based on the data shown in Figure 6, it can be explained that as many as 45.5% and 29.6% of respondents answered that the pedestrian path at ITERA was in a very bad condition when viewed and used by pedestrians. And as many as 29.1% of respondents said that the condition of the pedestrian path was good because in some parts of the zone there were pedestrian paths whose shape and atmosphere were quite adequate. 1.8% of respondents thought that the pedestrian path was very good. Based on the results of the respondents' evaluation, it can be seen that the condition of the pedestrian zone is still not good and needs to be improved.

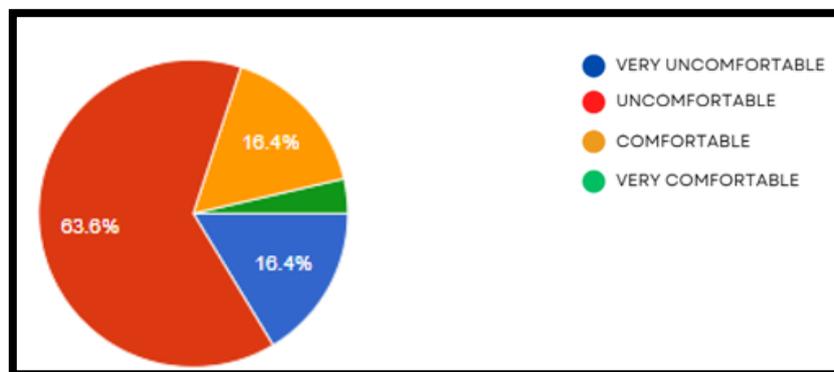
Figure 7 Diagram of respondents' assessment of walkway comfort

Based on the data shown in Figure 7, it can be explained that the comfort when going through the pedestrian path at ITERA is 63% of respondents answered less comfortable. Even as many as 16.4% of respondents answered very uncomfortable because many pedestrian path facilities at ITERA were inadequate so that the level of comfort was very bad for its users. A positive assessment of respondents who stated that the pedestrian path was comfortable at 16.4% and very comfortable at 3.6%. From the data above it can be concluded that the pedestrian path in ITERA have not met comfort standards based on user perceptions.

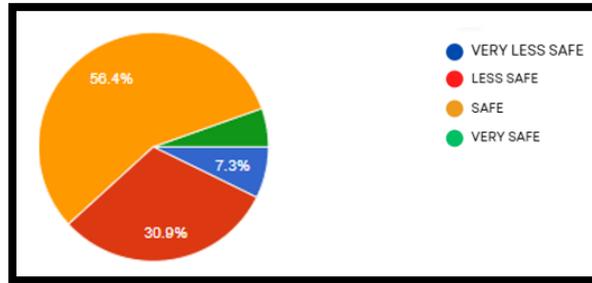
Figure 8 Diagram of respondents' assessment of walkway safety

Based on the data shown in Figure 8, it can be explained that as many as 56.4% of respondents said the pedestrian path was still safe when passed and 30.9% of respondents said it was less safe because there were several pedestrian paths that did not exist so that pedestrians passed through the shoulder or roads that should not be passed by pedestrians. 7.3% said the pedestrian path while the remaining 5.4% of respondents said that the pedestrian path was very safe. from the data obtained shows that the pedestrian path has fulfilled user safety but needs to be improved especially in areas where there are no pedestrian facilities.

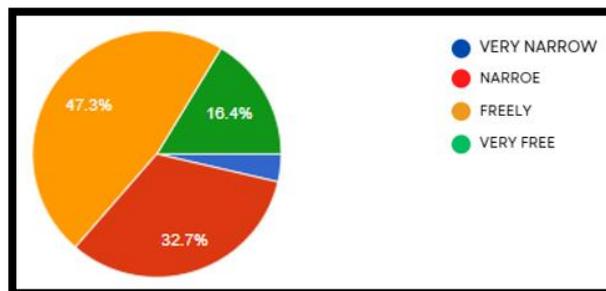
Figure 9 Diagram of respondents' assessment of walkway circulation

Based on the data shown in Figure 9, it can be explained that as many as 47.3% of respondents said that the pedestrian circulation was quite free when passed by pedestrians. However, as many as 32.7% of respondents said that the pedestrian circulation was still narrow so that it was less free while passing through the existing path, as many as 16.4% of respondents stated that the pedestrian circulation was very wide because there was still a lot of empty land on the side of the road shoulder that could be used for walking. while the remaining 3.6% of respondents said that the circulation was very narrow. from the data obtained it can be said that the circulation of the pedestrian path is sufficient to accommodate users.

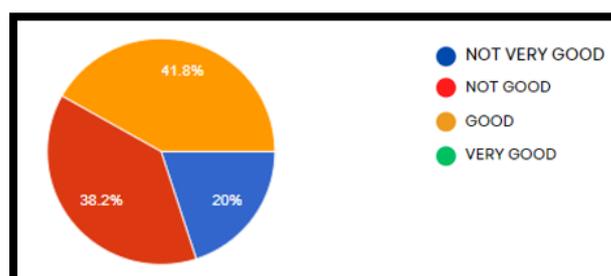
Figure 10 Diagram of respondents' assessment of the condition of pedestrian path vegetation

Based on the data shown in Figure 10, it can be explained that 41.8% of respondents said that there was already vegetation in some areas of the pedestrian path so that it made the area shady. However, 38.2% of respondents said it was not good because the vegetation planted did not shade the pedestrian area so that it felt hot when passed during the day. 20% of respondents stated that the vegetation was very poor. based on the data above and in accordance with field data, it shows that the pedestrian path as a whole does not yet have shady vegetation considering that ITERA is a new campus so that the vegetation planted has not grown shady in all areas. it is necessary to arrange vegetation that is designed for pedestrians so that it not only becomes shady but becomes the aesthetics of the campus area.

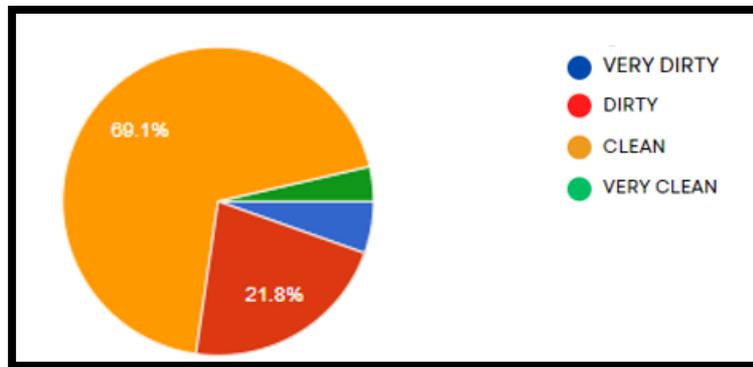
Figure 11 Diagram of respondents' assessment of walkway cleanliness

Based on the data in Figure 11, it can be explained that the pedestrian paths are mostly clean and only about 21.8% of respondents stated that they are dirty because some paths still have dry leaves scattered because they are not reached by janitors or because the wind is strong so that the leaves of the vegetation fall off quickly. other respondents of 5.3% stated that the pedestrian paths were very dirty while the remaining 3.8% stated that they were very clean. Based on the data obtained and then adjusting the facts in the field, it can be concluded that the overall cleanliness condition of the pedestrian path is clean considering that there are janitors who routinely clean the pedestrian path, as for respondents who consider that the pedestrian path is still dirty, it shows that there are still some areas that are close to vegetation and there are many dry leaves falling.

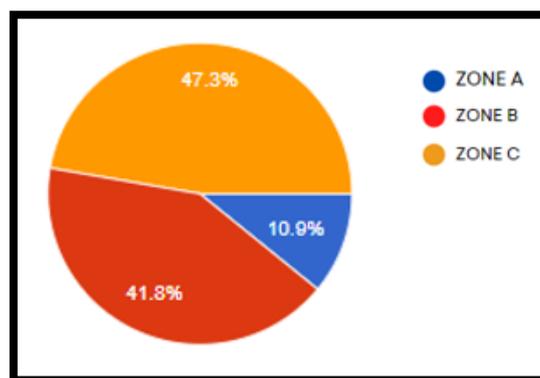
Figure 12 Diagram of respondents' assessment of the overall condition of pedestrian paths in each zone

Overall, the road conditions described in Figure 12 show that, the assessment of Zone C which has the highest percentage of respondents, namely 47.3% of respondents, said that in this zone pedestrian users feel uncomfortable from the 7 aspects above and inadequate sidewalks. Then, the second uncomfortable pedestrian path is in Zone B as many as 41.8% of respondents answered in this zone because activities are often passed so that the comfort of shade vegetation is inadequate. And as many as 10.9 respondents said that in Zone A the pedestrian path has many adequate facilities, such as free space, sidewalks, and shade vegetation.

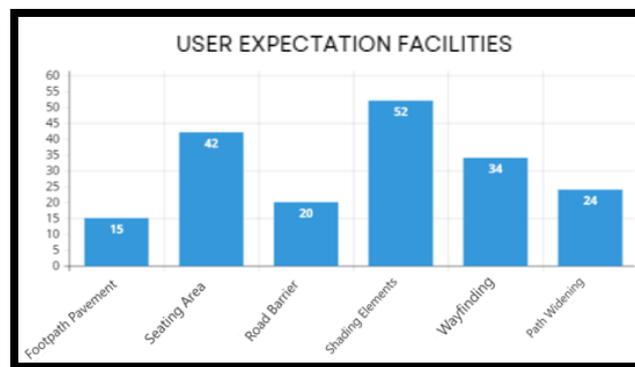
Figure 13 shows that 94.55% of respondents expressed their desire to have shade trees along the walkway to improve pedestrian comfort and reduce the heat of the sun during the day. This finding is in line with existing pedestrian walkway design principles, which emphasize the importance of vegetation in providing shade, reducing heat stress, and creating a more aesthetically pleasing environment. In addition, 76.36% of respondents requested seating facilities, such as park benches, for this purpose. The provision of seating along pedestrian paths is essential to enhancing comfort and relaxation among users, especially for those with limited mobility. In addition, 62.82% of respondents requested informative signage. Clear and well-placed signage plays an important role in guiding pedestrians, ensuring safety, and improving the overall user experience. The survey results further showed that 43.64% of respondents wanted wider pedestrian paths. Wider paths can accommodate increased pedestrian traffic, reduce congestion, and provide a more comfortable and inclusive environment for all users. In addition, 36.36% of respondents requested safety barriers that separate pedestrians from vehicular traffic. The implementation of physical barriers, such as curbs or bollards, is essential to protect pedestrians from vehicle hazards and ensure their safety. Finally, 27.27% of respondents requested paved pedestrian paths. Paved walkways offer a smooth, stable, and accessible walking surface, especially during inclement weather conditions.

Figure 13 Diagram of respondents' assessment of expected pedestrian path conditions
