# Measuring and Improving Walkability in Urban Historical Tourism Area: A Case Study in Medan

<sup>1</sup>Department of Architecture, Faculty of Engineering, Universitas Sumatera Utara, Medan, 20155, Indonesia

Medan is the largest city on Sumatera Island and the capital city of North Sumatera. The main tourist attractions are in the downtown area, which is located in the Kesawan corridor, around Lapangan Merdeka, Maimun Palace, and the Al Mashun Grand Mosque. However, there is still no adequate walking environment that connects those areas which resulting in very little walking activity. This research aims to to assess the current condition of the walking environment and develop a design model in order to enhance walkability in the historic tourism areas of Medan. The authors undertake a field survey as well as collect the pedestrians preference regarding the walkway. The final walkability score of the research locations are 58,8. The authors proposed five model recommendation to improve the walkway in the research locations, namely: (1) Walkway amenities improvement; (2) CPTED design application in the walkway; (3) Implementation of pelican crossing; (4) Signage and speed bump a

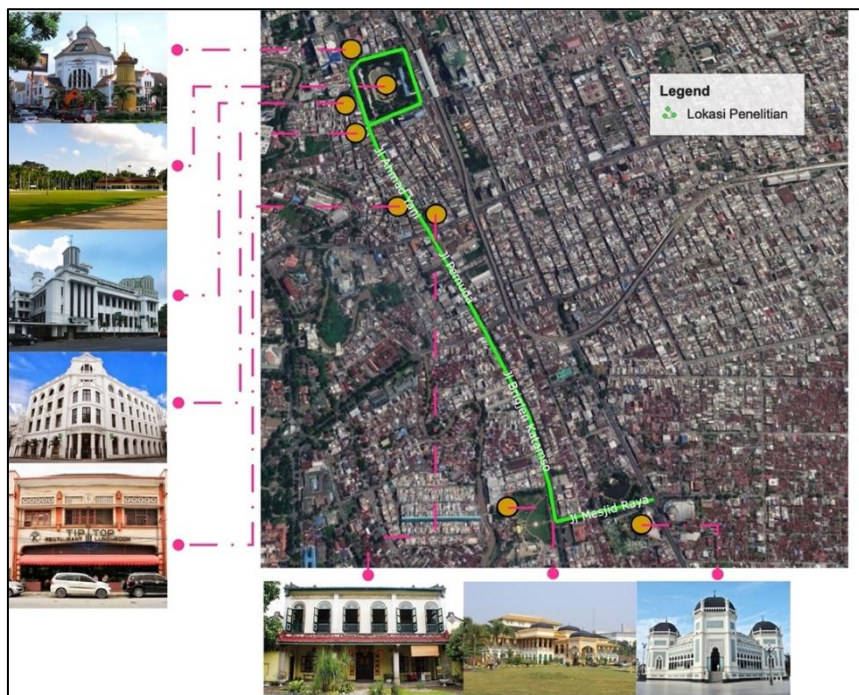
**Figure 1.** Research location

This study employed a mixed-method approach combining a structured field walkability audit and a pedestrian questionnaire survey. The field audit was used to assess the physical and environmental quality of pedestrian facilities, while the questionnaire survey was conducted to obtain pedestrians' perceptions, travel behaviour, and preferences for walkway improvement. The combination of these two methods was intended to provide both objective and user-based evidence for formulating walkability improvement recommendations in Medan's historical tourism area. The study was conducted in Medan City, North Sumatera, Indonesia, focusing on the main historical tourism corridor that connects several important destinations, including Al Mashun Grand Mosque, Maimun Palace, the Kesawan corridor, Lapangan Merdeka, and Kantor Pos. As shown in Figure 1, the study area extends from Al Mashun Grand Mosque in the southern part of the corridor to Kantor Pos in the northern part. The corridor was divided into five observation segments to allow a more detailed and comparable assessment of pedestrian conditions. These segments consist of the Mesjid Raya corridor, Brigjen Katamso corridor, Pemuda corridor, Ahmad Yani corridor, and the corridor around Lapangan Merdeka. The approximate length of each segment is presented in Table 1.

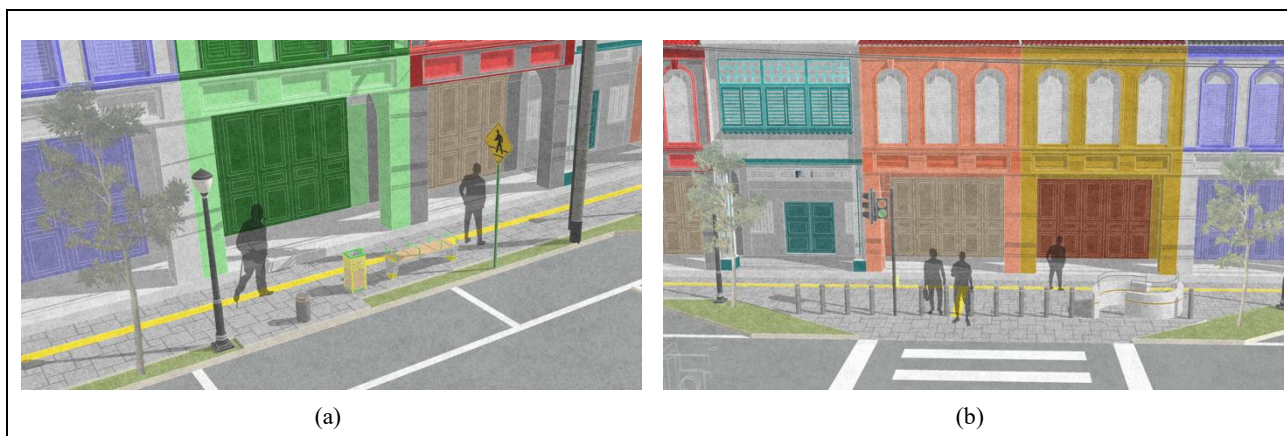
Based on the combined results of the field audit and pedestrian questionnaire, the first improvement strategy is to enhance walkway width, continuity, surface quality, and amenities. Figure 15 illustrates the proposed

improvement of pedestrian amenities, including benches, litter bins, bollards, street lighting, and vegetation. The proposed walkway width of approximately 2.5 to 3.5 meters would provide a more comfortable walking space and reduce conflict between pedestrians and surrounding activities. Bollards and vegetation can prevent vehicles from entering the pedestrian path, while durable, firm, anti-slip, and relatively rough pavement materials can improve safety and usability. This recommendation is consistent with previous research emphasizing the importance of appropriate walkway material and physical quality in supporting pedestrian movement [18]. The design approach also responds to the respondent preference for removing obstructions and improving amenities, as shown in Figure 14. The second strategy is the application of Crime Prevention Through Environmental Design (CPTED) principles. Figure 16 presents the proposed CPTED-based design, which includes clearer access control, improved surveillance, pedestrian-level lighting, CCTV placement, vegetation buffers, and stronger territorial definition between pedestrian and vehicular spaces. This recommendation is important because several corridors recorded only fair scores for security from crime, and safety and security were among the main concerns identified by respondents. CPTED has been widely discussed as an effective environmental design approach for reducing safety-related incidents in public infrastructure and urban spaces [19][20]. In the context of Medan's historical tourism corridor, CPTED can support both pedestrian safety and the protection of adjacent buildings and parking areas [21]. However, its implementation should be integrated with active street frontage, maintenance, lighting management, and local security coordination to avoid relying solely on surveillance devices.

**Figure 15.** Walkway amenities improvement

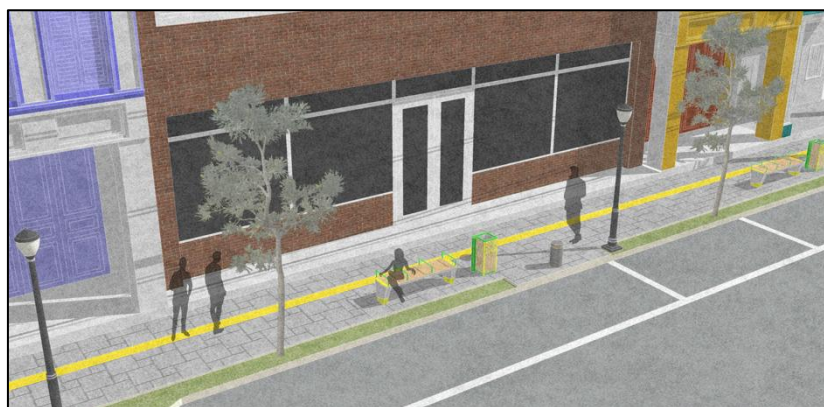
**Figure 16.** CPTED design

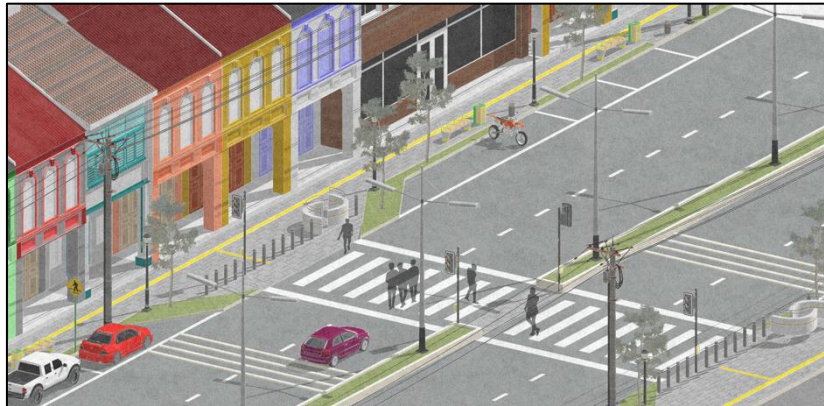
The third strategy is the provision of safer pedestrian crossing facilities. Figure 17 illustrates the proposed pelican crossing, which is relevant because crossing availability received the lowest average parameter score in Table 5. The lack of safe crossings forces pedestrians to cross at informal or unsafe points, increasing exposure to traffic risk. Pelican crossings equipped with pedestrian call buttons can provide a clearer and safer crossing opportunity, especially in corridors with high pedestrian demand and vehicle movement. The placement of these crossings should be based on observed pedestrian desire lines, destination nodes,

**Figure 17.** Pelican crossing

| Parameter | Avg. Score | Recommendation |
|---|---|---|
| Availability of crossings | 28 (poor) | Inadequate amount of crossing facility in all locations. Increased crossing facilities, such as the Pelican crossing, which is equipped with a crossing call button, could provide solutions. |

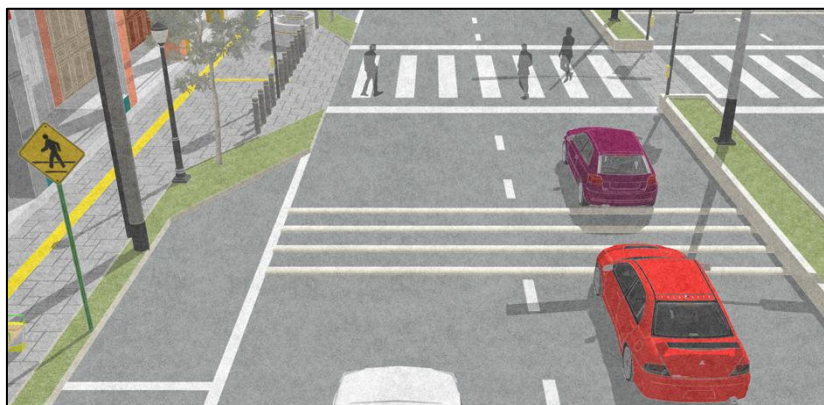
The fourth strategy concerns traffic calming through the use of speed bumps and warning signage. Figure 18 shows the proposed application of speed bumps and pedestrian warning signs before crossing points. This intervention is necessary because motorist behaviour and grade crossing safety were among the weaker parameters in the field assessment. Traffic calming can reduce vehicle speed, increase driver awareness, and improve pedestrians' perceived and actual safety when crossing the street. Previous research has shown that lower vehicle speed and safer street environments contribute to better pedestrian safety and comfort [23]. In the Medan context, this strategy is particularly relevant for corridors where motorcycles and angkutan kota frequently drive aggressively or stop unpredictably. The final strategy is the provision of accessible ramps and S-portal barriers. Figure 19 illustrates the proposed ramp and S-portal barrier design, which aims to improve access for wheelchair users while preventing motorcycles from entering the pedestrian path. This recommendation responds directly to the limited disability infrastructure observed in most corridors. Although tactile paving exists in several locations, ramps are absent or too steep in many segments, meaning that the pedestrian environment is not yet inclusive. The S-portal barrier can serve as an alternative to conventional bollards because it restricts motorcycle access while still allowing wheelchair movement. Nevertheless, the design must be carefully dimensioned to ensure that it does not create a new obstruction for people with disabilities, older adults, children, or pedestrians carrying goods.

**Figure 18.** Signage and speed bump

| Parameter | Avg. Score | Recommendation |
|---|---|---|
| Grade crossing safety | 44 (fair) | When crossing the street, pedestrians are often exposed to other vehicles. There are preventative measures that can be used, such as speed bumps and speed limit signage |

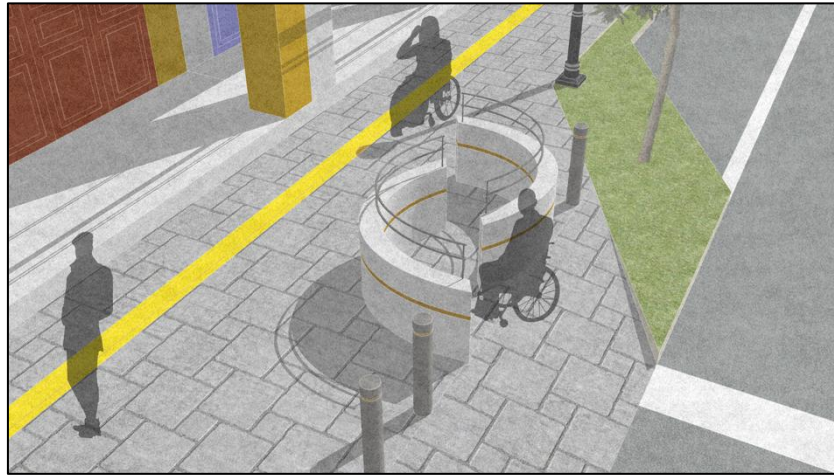
**Figure 19.** Ramp and S portal barrier

| Parameter | Avg. Score | Recommendation |
|---|---|---|
| Disability infrastructure | 60 (fair) | Braille tactile paving is already equipped in most locations. However, only few locations are providing ramp despite being too steep for wheelchair. Build a modest ramp may increase the walking experience. |
