# Arrangement of Special Region in Corridor Dr. Mansyur

**Abstract.** Medan is one of the largest cities in Indonesia after the metropolis of Jakarta also experienced strip development that has shown symptoms in the suburbs. The symptoms can be identified from the aspect of land use on the outskirts of Medan in this case usually rural regions are characterized by agrarian areas switching functions to non-agrarian land, seen from the qualities of buildings in the suburbs, almost all buildings distinguished by urban or non-sectoral agrarian in a review of the building characteristics also added about the density of buildings and the number of buildings in a particular area. One of them is the problem that occurred in the corridor Dr. Mansyur. The original road capacity for calm residential traffic can no longer accommodate the dynamics of commercial activities. Traffic congestion, parking vandalism, pedestrian route malfunctioning by street vendors, the emergence of portable stands, and tent stalls on the edge of the road. The consideration will be based on predetermined variables, namely, elements of the city image, specifically paths, boundaries, regions, vertices, and landmarks.

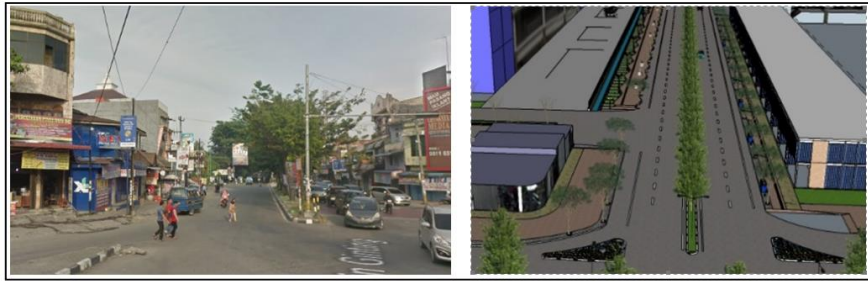
**Figure 2** Existing Condition (left) Pre-existing Design (right)

This segment is the main route in Dr. Mansyur. This is because this segment is a meeting between Jamin Ginting street and Dr. Mansyur street. This segment is a reasonably busy lane with many private vehicles and public transportation, such as public transport. Unfortunately, in this segment, the need for pedestrian lines is inadequate. Because it will be designed as a proper

pedestrian so that it can meet the needs of its users. Also, additional elements, such as chairs, will be added (Figure 2).

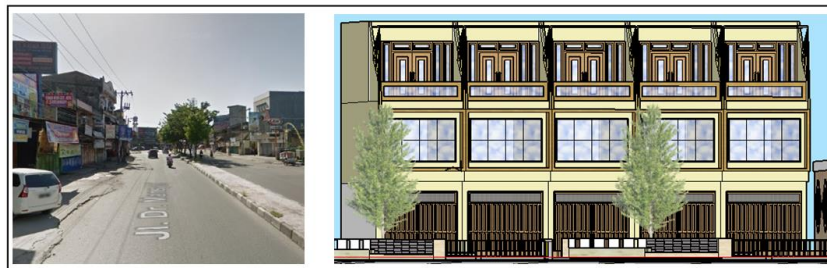
**Figure 3** Shopping Conditions (left) and Shop Pre-Design (right)

The main principles applied to commercial passages related to this pedestrian route are: creating a sustainable pedestrian path along commercial corridors, develop corridors oriented to pedestrian comfort through structuring the road landscape and harmonious circulation system, develop pedestrian pathways that are easily accessible by cross-gender and different ability people, equipping pedestrian lines with adequate signage and elements, and the dimensions of the pedestrian path are 3-4 m (Figure 3).

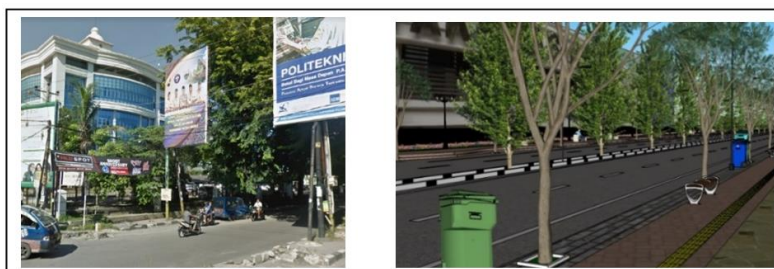
**Figure 4** Road condition (left) and Pre-designed road (right)

The condition of the shops in this segment is very chaotic. This because the number of advertisements that are placed carelessly on the building so that it causes shopping buildings in this segment does not look good, so it seems slum. The condition of passage in this segment is also inadequate. So that a shop will be designed with an adequate corridor to meet the needs of its users, it is equipped with vegetation that functions as a shade and barrier to air pollution (Figure 4).

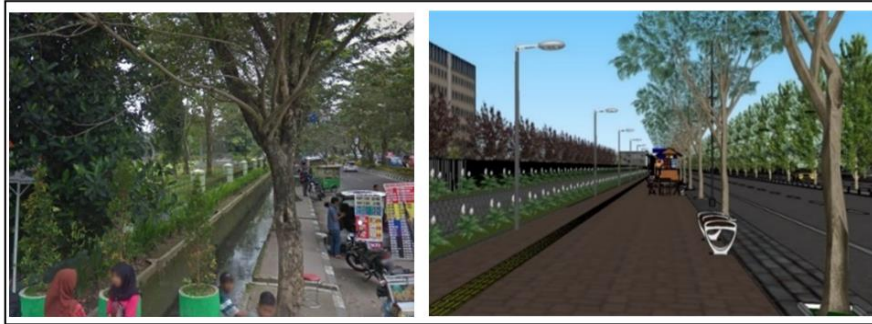
**Figure 5** Pedestrian condition (left) and Pedestrian Pre-Design (right)

Road conditions in this segment are quite good, but street furniture in this segment has not been accommodated. So that roads and corridors that have been provided with street furniture will be designed along with pedestrian ways to increase pedestrian comfort. On the highway corridor, lights will be placed on the road that leads to the side of the way to illuminate the passage and the main road. The distance between lamps is 15 m (Figure 5).

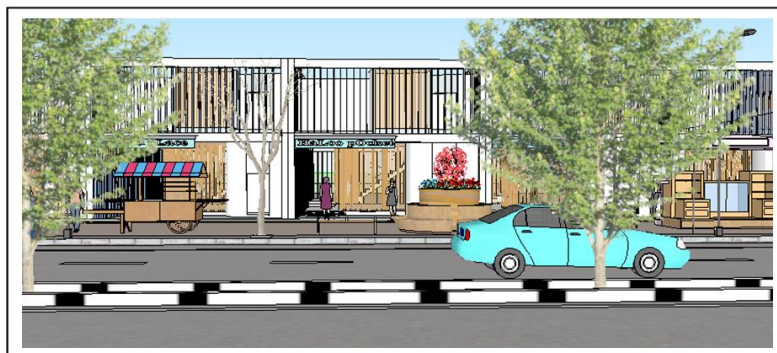
**Figure 6** Shop Pre-designed

The main point in this pre-design concept is the provision of locations for street vendors who are not arranged in the corridor of the road along this segment. Where the street vendors choose a place to open a business along the pedestrian lane so the road corridors are not used as they should. The concept in this pre-design emerged from the comparative study and literature review of the State-Madison WI USA road corridor, where the existence of pedestrian lanes and shops/restaurants was not eliminated but was given a boundary between pedestrian paths and shop/restaurant (Figure 6).

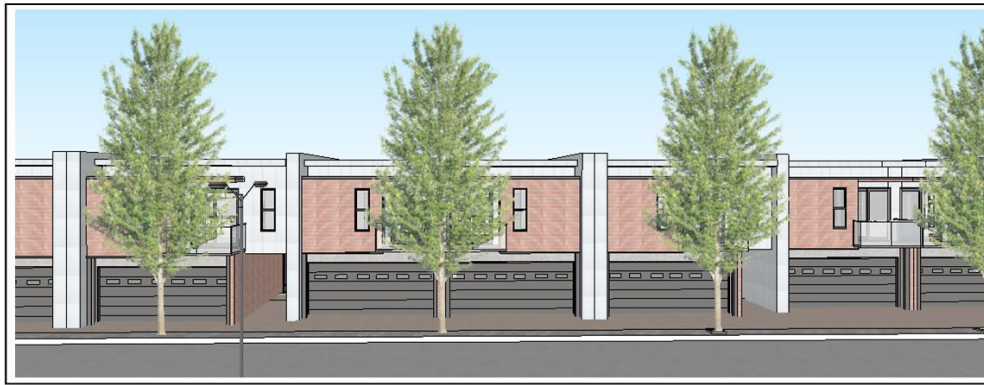
**Figure 7** Shop Pre-Design

The addition of new elements or details adapted to the old style. You can add artificial lighting effects to make it more dramatic. Windows and facades are given a unique color touch. Green layout planning still uses the existing tree. Angsana tree that has a function as a shade and maintains the characteristics of the area through vegetation, and using artificial lighting along the corridor (Figure 7).

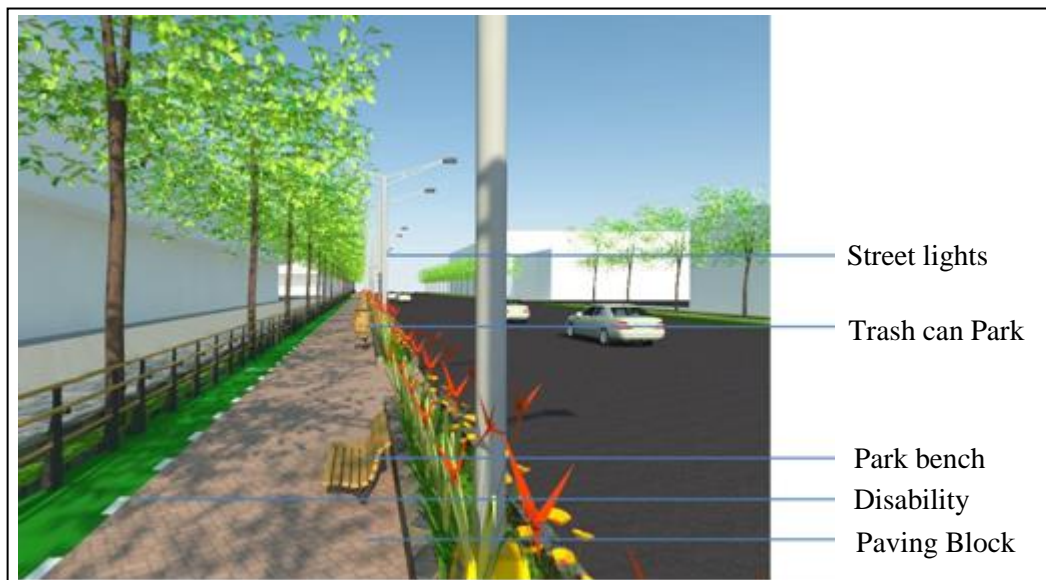
**Figure 8** Pre-designed

The condition of the shops in this segment is very chaotic. This because the number of advertisements that are placed carelessly on the building so that it causes shopping buildings in this segment does not look good, so it seems slum. The condition of the corridor in this segment is also inadequate. So that a shop will be designed with an adequate passage to meet the needs of its users; moreover, it was equipped with vegetation that functions as a shade and barrier to air pollution. The plant will be placed on pedestrian ways in the form of shrubs. In this area, street furniture will also be set to increase the comfort of pedestrians. On the main road, street lights will be placed that lead to the side of the way. Garbage bins are placed at intervals of 20 meters apart (Figure 8).
