Failure Mechanism Identification of Hook Components in Automatic Machines Using Visual and Material Analysis

Nabila Desy Rahmawati^{1*} and Lutiyatmi²

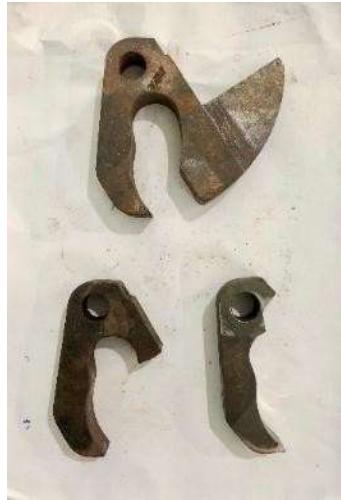
Figure 2. Sample hook.

The fractured hooks (shown as Figure 2) were examined using the naked eye to identify fracture characteristics such as flatness, texture, and presence of deformation or striations. This observation provided an initial understanding of the fracture mechanism.
