Analysis of tree quality on the green line using google earth in Tanjung Morawa District, Deli Serdang Regency

Samsuri¹, Esterlina Napitupulu¹, Alfian Gunawan Ahmad¹, Anita Zaitunah^{*1}

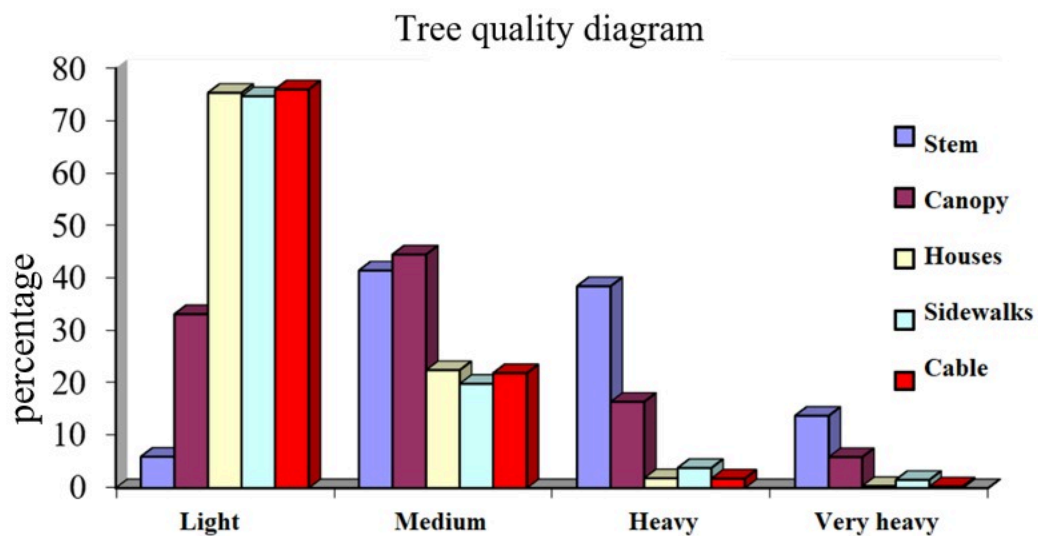
Figure 8. Tree quality diagram on the green line of Tanjung Morawa sub-district

The quality classes of trees on the green line are different (figure 8). This depends on the type of plant / tree and the adaptability of tree species to the surrounding environment. According [12] said that forest function is influenced by the quality of tree health. The optimal function of a forest runs if the constituent trees in the forest are in good condition.
