Analysis of the Surface Matrix of Copper Cable in Jointing as the Effect of Increasing Current and Heating on Fire Application

S. Hasugian, S. Hasan, A. H. Rambe and Supiyani, "Analysis of the Surface Matrix of Cable in jointing as the effect of increasing current and heating on fire application," Journal of Technomaterial Physics, vol. 06, no. 01, pp. 40-46, Feb. 2024, doi: 10.32734/jottp.v6i1.15777.

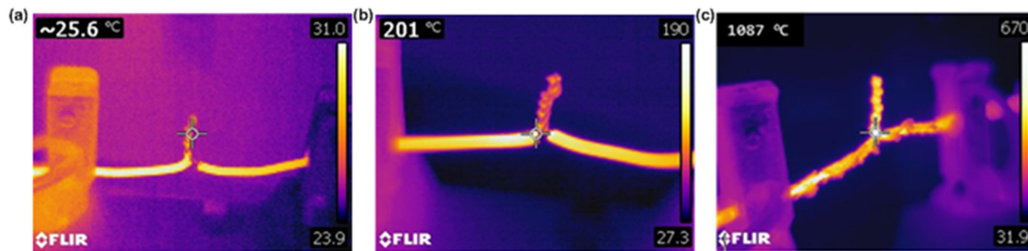
Figure 2. FLIR images of fire experiment: (a) standard PUIL sample of 25.6°C (sample A), (b) B PUIL sample of 201°C (sample B), and (c) C PUIL sample of 1087°C (sample C).

The copper cable utilized was NYA type, featuring PVC insulation with a diameter of \varnothing 1.5 mm² (046620.3 Eterna CU/PVC 1.5 mm² 450/7500 NYA), as depicted in Figure 1. The cable underwent in situ experiments with the following variations: Sample A (PUIL jointed standard cable, temperature maintained at 25.6°C for 30 minutes), Sample B (PUIL jointed cable exposed to normal heating reaching 201°C for 30 minutes), and Sample C (PUIL jointed cable subjected to severe heating resulting in burn damage reaching 1087°C for 4 minutes), as shown in Figure 2.

Based on the material data of the samples used in this study, the following table and figure illustrate the relationship between current and heat observed in the fire experiment. Figure 2 displays images captured during the fire experiment using FLIR at 25.6°C, 201°C, and 1087°C.

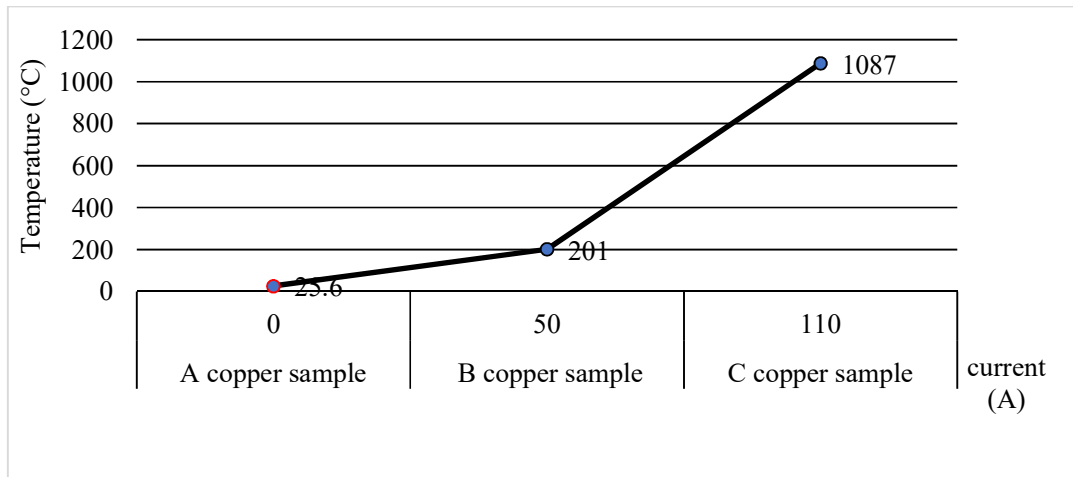
Figure 3. Graph of the relation between current and heat.

In Table 1 and Figure 3, it is evident that the surface matrix heat of copper cable joints increases proportionally with the rise in current and heat. The greater the current strength, the higher the surface temperature of the copper. Variations in current significantly impact changes in conductor temperature, with proximity to the heat source resulting in higher temperatures.

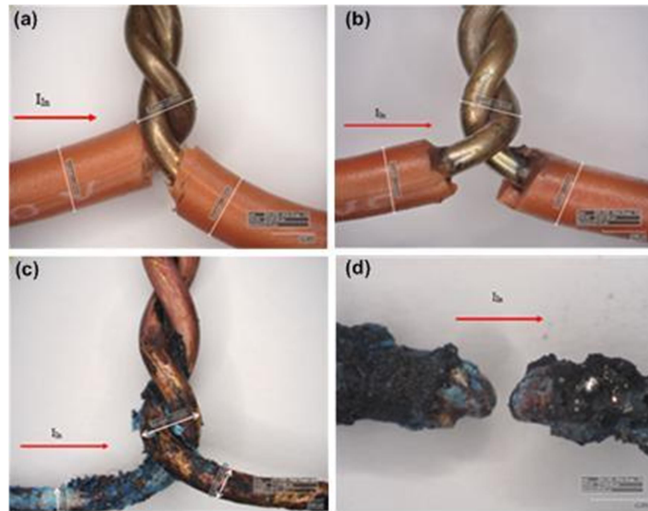
Figure 4. Hirox digital microscope images with 20 times magnification : (a) standard PUIL sample of 25.6°C (sample A), (b) PUIL sample of 201°C (sample B), (c) PUIL sample of 1087°C (sample C), and (d) PUIL sample of 1087°C in burnt.

Figure 4(a) shows the macro analysis of A sample of PUIL in jointing using Hirox with 20x magnification. It appeared that the inside of the insulating sheath was still intact (there are no signs of the pyrolysis process). At the same time, there was no soot on the cable core; it showed a heat transfer value of 0 A current for 30 minutes of 25.6°C (maximum operating temperature value) as PVC insulation in it can endurance heat transfer to reach normal conditions so that there were no signs of pyrolysis (carbonizing process). Figure 4(b) showed B PUIL in a jointing sample using Hirox with 20x magnification. It appeared that the inside of the insulation was still intact, but there were differences (there were signs of pyrolysis and carbonizing process), as the cable core already had soot. This indicated a heat transfer process of 50 A for 30 minutes at 201°C (maximum operating temperature value) because PVC insulation was still resistant to increasing heat, indicating that the pyrolysis process did not occur. Figure 4(c) shows a D sample of PUIL in jointing using HIROX with 20 x magnification. It appeared that the inside of the insulating sheath was still intact, but there were differences (there were signs of pyrolysis and carbonizing process). At the same time,

the cable core already had soot; this showed the heat transfer process from 110 A current for 4 minutes of 1087°C (heat value for melted copper cables) so that the partially burned PVC insulation material sticks to the copper conductor cable core. It caused the copper cable to melt when it reached overheating 1080°C. It caused the deformation of the cross-sectional area of the cable, which is observed in changes in the surface matrix of the burned cable structure following Figure 4(d).

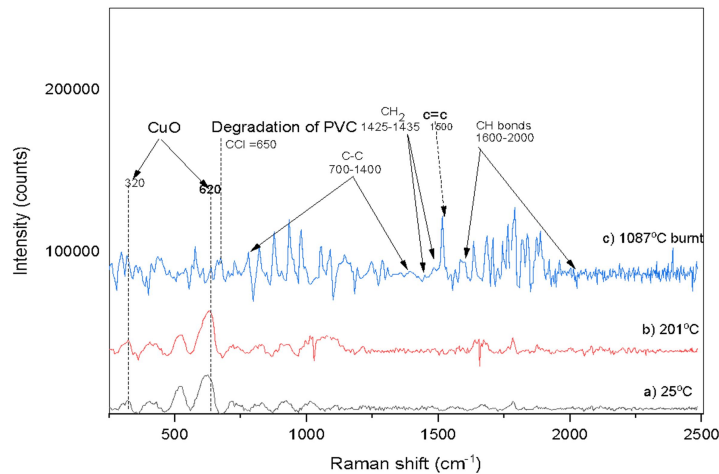
Figure 5. Raman spectrum of copper cable from three samples.

Figure 5 reveals that the third sample contains CuO, as evidenced by absorption peaks at 320 and 620 cm^{-1} wavelengths. Sample C, subjected to maximum heat, led to the melting of the copper cable, consistent with

the theory that copper melts at temperatures exceeding 1080°C, resulting in pyrolysis of the protective PVC cable and subsequent combustion. Sample C demonstrates PVC degradation through Raman spectrum analysis, revealing evidence of PVC pyrolysis. Specifically, PVC components adhered to the surface of the copper cable matrix. Notably, absorption peaks at 650 cm^{-1} suggest the presence of CCl, while absorption in the range of 100-1400 cm^{-1} indicates the presence of C-C bonds, and absorption at CH bending short bonds appears at 1600-2000 cm^{-1} . PVC degradation is further evidenced by absorption at 1500 cm^{-1} , indicating the presence of C=C polyene double chains, and absorption at 1425-1435 cm^{-1} , indicating the appearance of short-chain CH_2 (a byproduct of the pyrolysis process).
