Analysis of the Surface Matrix of Copper Cable in Jointing as the Effect of Increasing Current and Heating on Fire Application

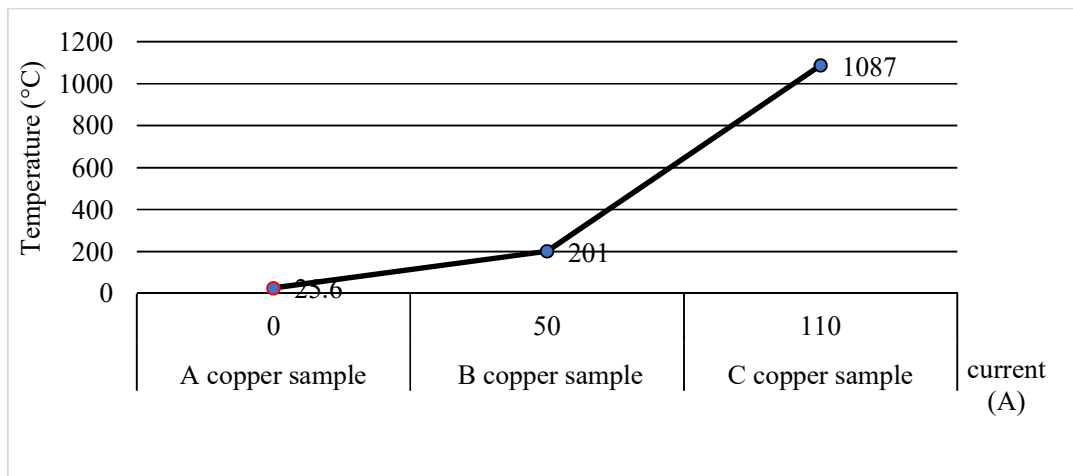
Figure 3. Graph of the relation between current and heat.

In Table 1 and Figure 3, it is evident that the surface matrix heat of copper cable joints increases proportionally with the rise in current and heat. The greater the current strength, the higher the surface temperature of the copper. Variations in current significantly impact changes in conductor temperature, with proximity to the heat source resulting in higher temperatures.

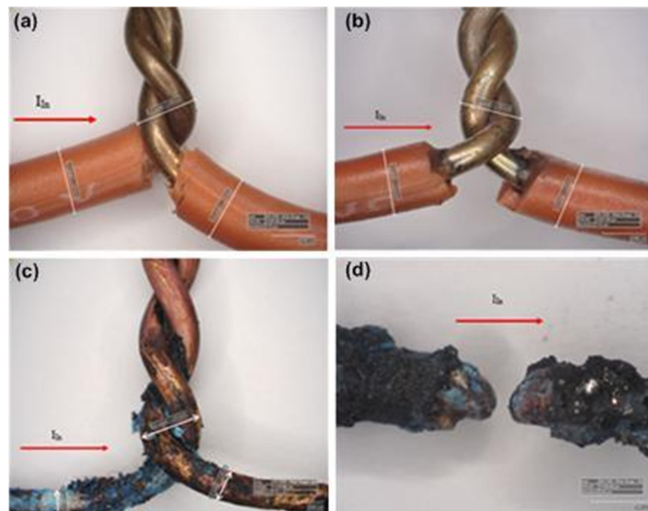
Figure 4. Hirox digital microscope images with 20 times magnification : (a) standard PUIL sample of 25.6°C (sample A), (b) PUIL sample of 201°C (sample B), (c) PUIL sample of 1087°C (sample C), and (d) PUIL sample of 1087°C in burnt.

Figure 4(a) shows the macro analysis of A sample of PUIL in jointing using Hirox with 20x magnification. It appeared that the inside of the insulating sheath was still intact (there are no signs of the pyrolysis process). At the same time, there was no soot on the cable core; it showed a heat transfer value of 0 A current for 30 minutes of 25.6°C (maximum operating temperature value) as PVC insulation in it can endurance heat transfer to reach normal conditions so that there were no signs of pyrolysis (carbonizing process). Figure 4(b) showed B PUIL in a jointing sample using Hirox with 20x magnification. It appeared that the inside of the insulation was still intact, but there were differences (there were signs of pyrolysis and carbonizing process), as the cable core already had soot. This indicated a heat transfer process of 50 A for 30 minutes at 201°C (maximum operating temperature value) because PVC insulation was still resistant to increasing heat, indicating that the pyrolysis process did not occur. Figure 4(c) shows a D sample of PUIL in jointing using HIROX with 20 x magnification. It appeared that the inside of the insulating sheath was still intact, but there were differences (there were signs of pyrolysis and carbonizing process). At the same time,

the cable core already had soot; this showed the heat transfer process from 110 A current for 4 minutes of 1087°C (heat value for melted copper cables) so that the partially burned PVC insulation material sticks to the copper conductor cable core. It caused the copper cable to melt when it reached overheating 1080°C. It caused the deformation of the cross-sectional area of the cable, which is observed in changes in the surface matrix of the burned cable structure following Figure 4(d).
