Analysis of the Evacuation Route Effectiveness Based on the Hotel's Visitor Evacuation Speed (Case Study: Grand Kanaya Hotel, Medan)

N. Vinky Rahman^{1}, Lenita Aulia Sinaga¹*

¹ *Architecture Department, Faculty of Engineering, Universitas Sumatera Utara, Medan, Indonesia*

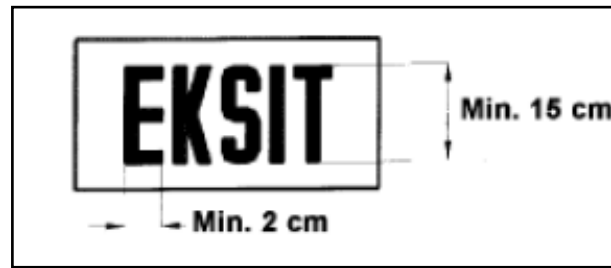
Figure 2. Signage standard size
(Source: SNI 03-6574-2001)

The size of the direction sign that reads "EKSIT" or other suitable words, with letters that are easy to see, a height of at least 15 cm, a letter thickness of at least 2 cm. The word "EKSIT" must have a letter width of at least 5 cm except for the letter "I" and a minimum distance between letters of at least 1 cm (Figure 2). Larger direction signs are made with width, thickness, and length of messages proportional to their height.

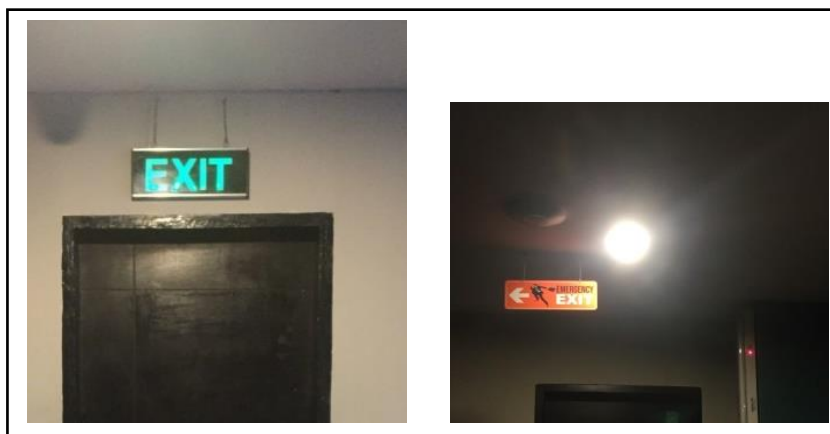
Figure 10. Exit Sign and its Location

The size of the direction sign is appropriate so that it can be easily seen. The installation location of the directional sign is suitable, which is placed at the intersection of the corridor (Figure 10). The presence of emergency lights in the hallway is appropriate, but there are no emergency lights on the emergency stairs (Figure 11). Gathering point is available around the Grand Kanaya Hotel (Figure 12), the minimum area required is 658m², the open space is 680 m² so that it is as needed.
