Physical and Non-Physical Factors Analysis of The Sukaramai Medan Traditional Market and Their Effect On The Area Accessibility Conditions

Abstract. Sukaramai Medan Traditional Market has several problems that happened during its development. One of the crucial issues is congestion caused mainly by traders who use the road to sell. From the compilation of data, Sukaramai Medan Traditional Market shows that it is getting busier and chaotic. Still, so far, there has been no significant improvement even though it interferes with user activity. This research was conducted to determine the problems in Sukaramai Medan Traditional Market based on physical and non-physical factors that affect access used as a guideline for improvement to create a more convenient area for market users. This study uses mixed methods between quantitative and qualitative methods with data collection used in the form of observations on the existing condition and surveying respondents that related. The several variables observed in the analysis are market location, trading rooms, and merchant mobility. Several physical and non-physical factors associated with congestion with the lowest value can be used as the

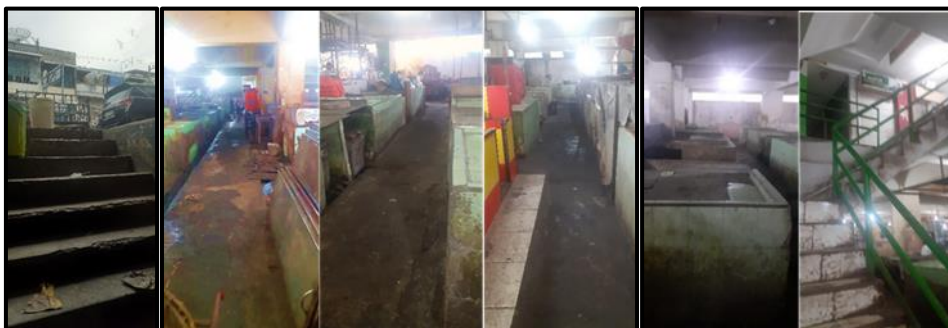
Figure 2 The condition of the basement of the Sukaramai Medan Traditional Market

The size of the counter is too small. In addition to materials in the Sukaramai Medan Traditional Market, many of the counters were cracked, not unkempt, and dirty (Figure 2). So that the traders of commodities damp using tarps to coat the counter table to be used to put stuff. Meanwhile, according to Menteri Kesehatan Republik Indonesia Nomor 519 Tahun 2008, concerning the implementation of healthy markets, materials for traditional market booths must be clean, sturdy, and easy to clean.

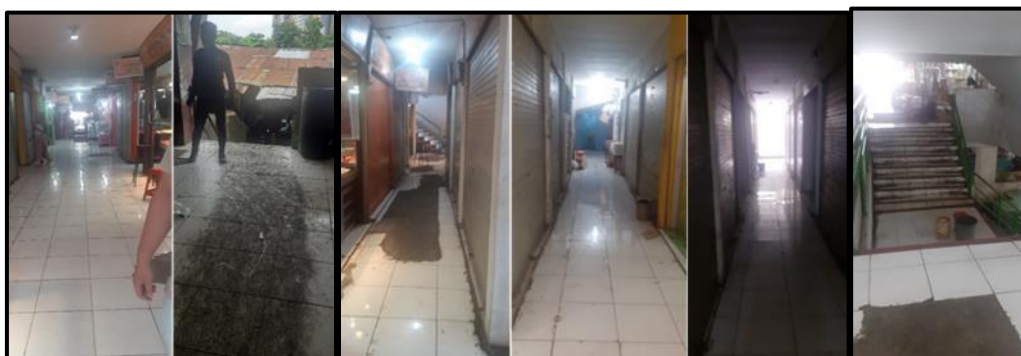
Figure 4 The condition of the first floor of the Sukaramai Medan Traditional Market

There is a difference that is quite significant in parts of the front and back of the corridor. The front of the corridor looks tiled and relatively clean, while the back looks less maintained. Structuring the location of the kiosk and counter in the Sukaramai Medan Traditional Market has not been arranged tidily. However, the position or location of the entire kiosk and counter can be passed quickly. The types of commodities that are similar are not in the same area, both on the first floor and basement, so it makes the buyer feel challenged to have to go around the corridor to look for needs that are required. These conditions can be seen in figure 4.

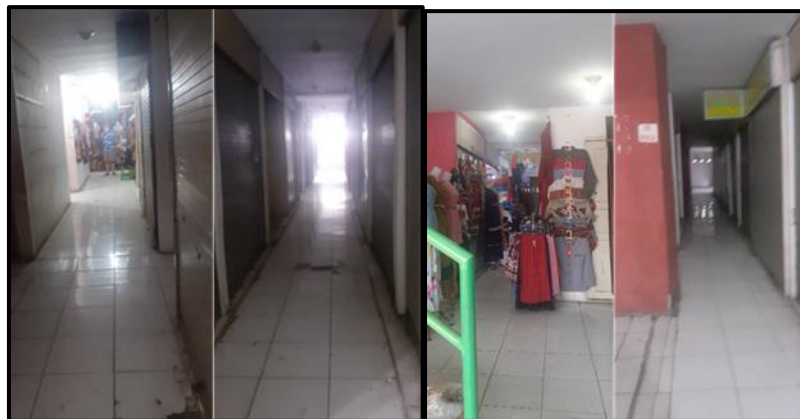
Figure 6 The condition of the second floor of the Sukaramai Medan Traditional Market

On the second floor, the arrangement location of retail devoted to commodity apparel, both types of clothes the kids to the adults. However, from the overall kiosks and stalls in the Sukaramai Medan Traditional Market, only a tiny amount of booths are being operated even though the shops' condition on this floor is more excellent than another floor (Figure 6). The number of kiosks and stalls closed affect the sale and purchase or power pull for visitors to shop at Sukaramai Medan Traditional Market.

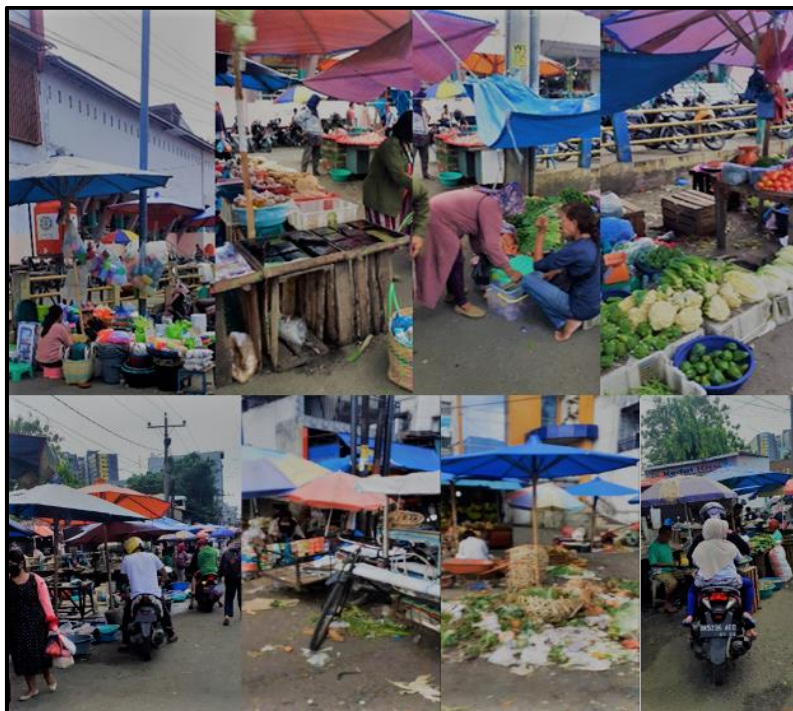
Figure 8 The condition of the outside of the Sukaramai Medan Traditional Market building

The Accessibility at the Sukaramai Traditional Market in Medan is inadequate due to the density of the seller's stalls, making it difficult for users to circulate. The distance between sellers is very tight so that the circulation to walk is narrow even to pass by an adult. In addition to the vehicle also deter most significant roads, things have led to the difficulty of using the facilities market, especially in the afternoon. This was happening because of the lack of parking facilities to accommodate the market, making the users use places that are supposed to be as access or circulation as a parking place. This condition can easily be seen in figure 8.
