# Water Quality Analysis of Batangtoru River in South Tapanuli District, North Sumatra Province

**Keywords:** *Batangtoru River, Industrial activities, Water Quality*

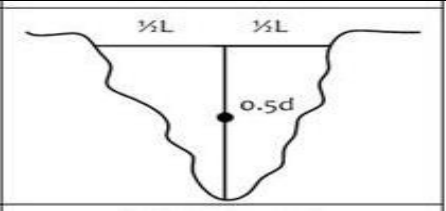
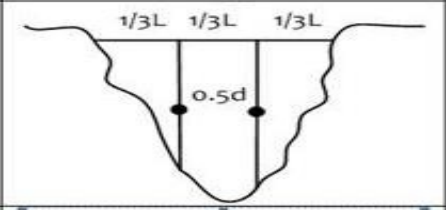
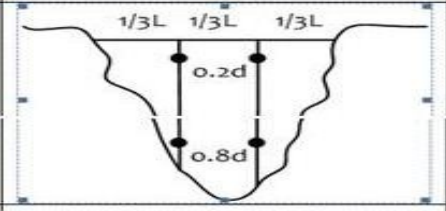
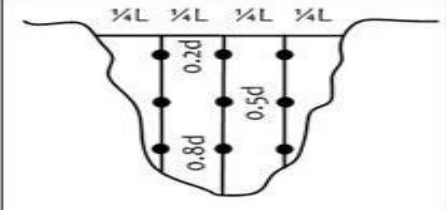
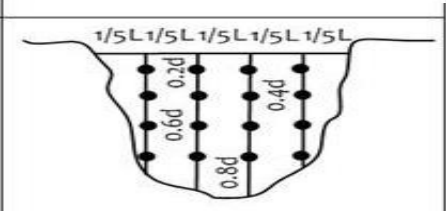
Table 2. Number of river water sampling points.

Average annual discharge (m <sup>3</sup> /det)	River Classification	Total Depth	Number of Sample Points
< 5 (Average depth < 1m)	Very Small	1

< 5 (Average depth > 1m)	Small	1

5 – 150	Medium	2

150 - 1000	Large	3

> 1000	Very Large	4

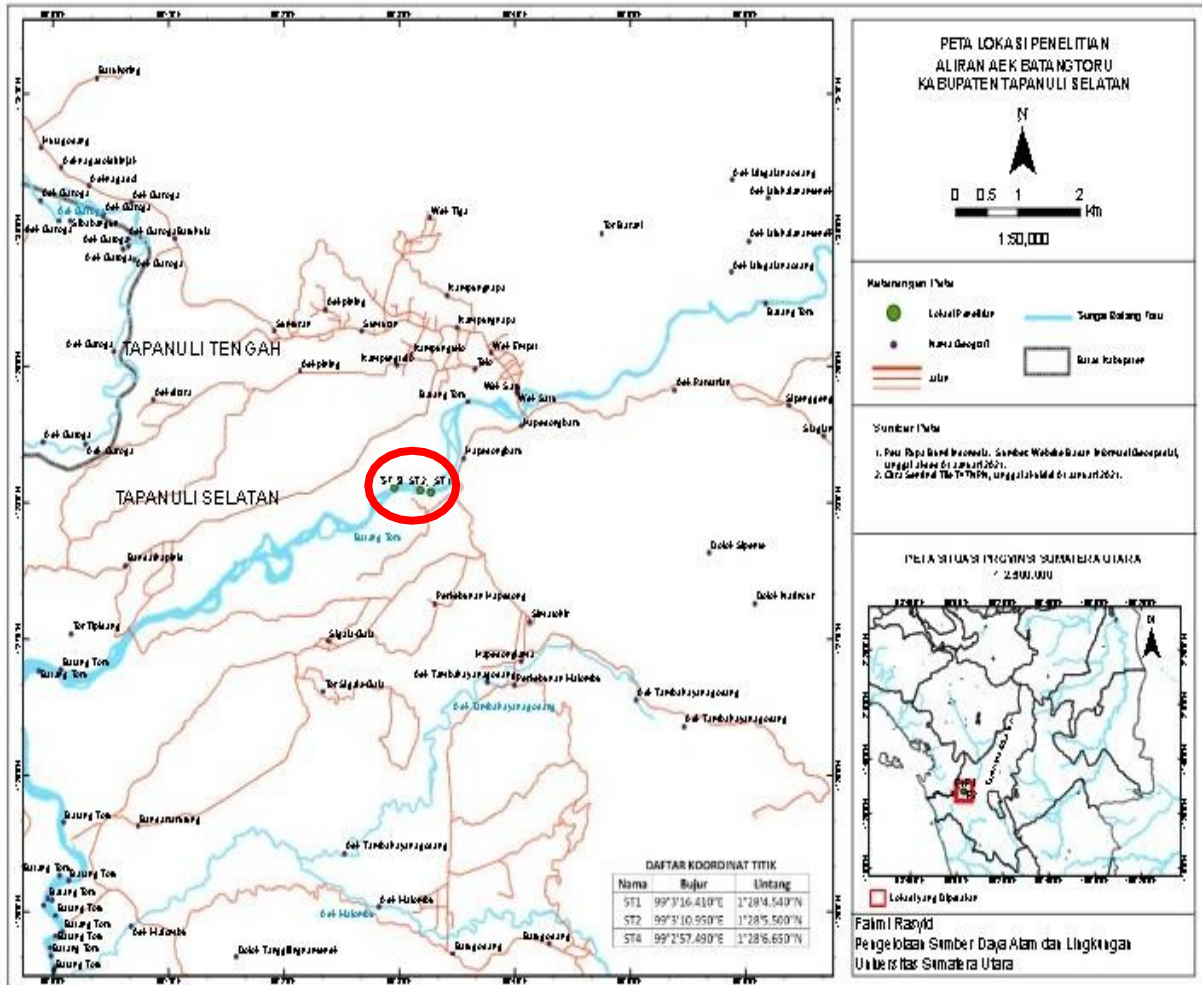
Figure 1. Sampling location map.

1. Station one (ST1) with coordinates North latitude 1°28'4.54" and East Longitude: 99°03'16.41"
2. Station two (ST2) with coordinates North latitude 1°28'5.50" and East Longitude: 99°03'10.95"

3. Station four (ST4) with coordinates North latitude 1°28'6.65" and East Longitude: 99°02'57.49"

The sampling location is in the Batang Toru River, South Tapanuli Regency, North Sumatra Province, Indonesia, where the sampling location is divided into three sampling locations. Specifically, the sampling locations are at stations and or sampling points (ST):

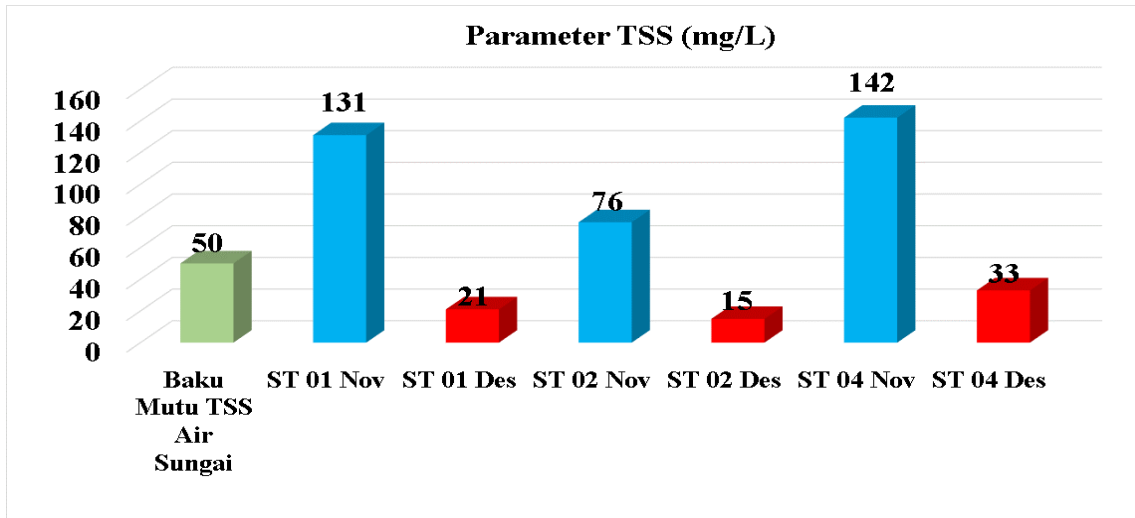
Figure 2. Concentration total suspended solid analysis (TSS).

In Figure 2 from the results of laboratory analysis, it can be seen that the Total Suspended Solid (TSS) value in November 2020 at the research locations (ST 1, ST 2, and ST 4) exceeded the quality standards based on PP 82 of 2001 with a TSS value of 131 mg/L at the ST 01 research location, a TSS value of 76 mg/L at the ST 02 research location and 142 mg/L at the ST 04 research location and the TSS value in December 2020 did not exceed.

The high TSS value of Batangtoru river water in November was due to the siltation of the river, a decrease in river discharge and soil erosion that was carried to the riverbed, the excavation of non-metallic mineral and/or rock mines (excavation C) around the Batangtoru river. According to the TSS concentration in the Batangtoru watershed exceeds the quality standard set by PP No. 82 of 2001 class II ( $> 50\text{mg/L}$ ) due to the presence of type C mining excavations. Furthermore, according to (Muchlisin, 2012) and (Nicola, 2015) TSS is solid material such as sand, mud, microorganisms, soil, and heavy metals suspended in water areas as a result of soil erosion and waste disposal that is carried into water bodies. Suspended solids consist of particles that are smaller in weight and size than sediment. These solids can settle immediately because they do not dissolve in water.

Based on field data and field observations, the high TSS value is due to sand extraction activities in the upstream area which is precisely above the ST 1 research location, and at the ST 4 location, there is mobilization of river sand and gravel materials taken from the Batangtoru river.

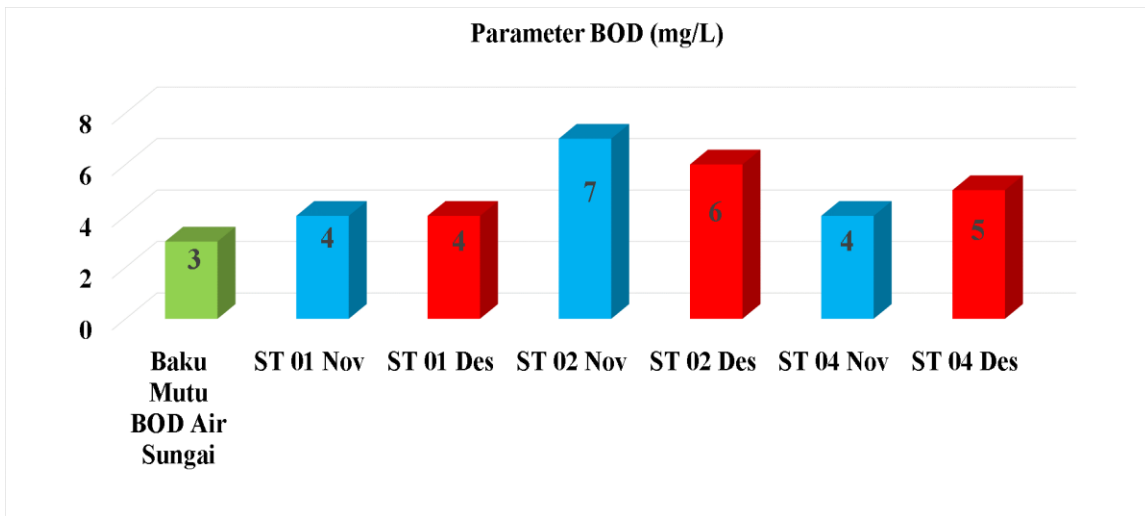
Figure 3. Concentration biological oxygen demand (BOD).

In Figure 3 it can be seen that based on the results of the analysis, the Biological Oxygen Demand value in the Batangtoru River at all sampling points exceeds the quality standard, indicating that there is organic waste discharged into the river body. According to (Rahmawati, 2011), organic waste materials are generally in the form of waste that can be decomposed or degraded by microorganisms, so when discharged into waters will increase Biological Oxygen Demand

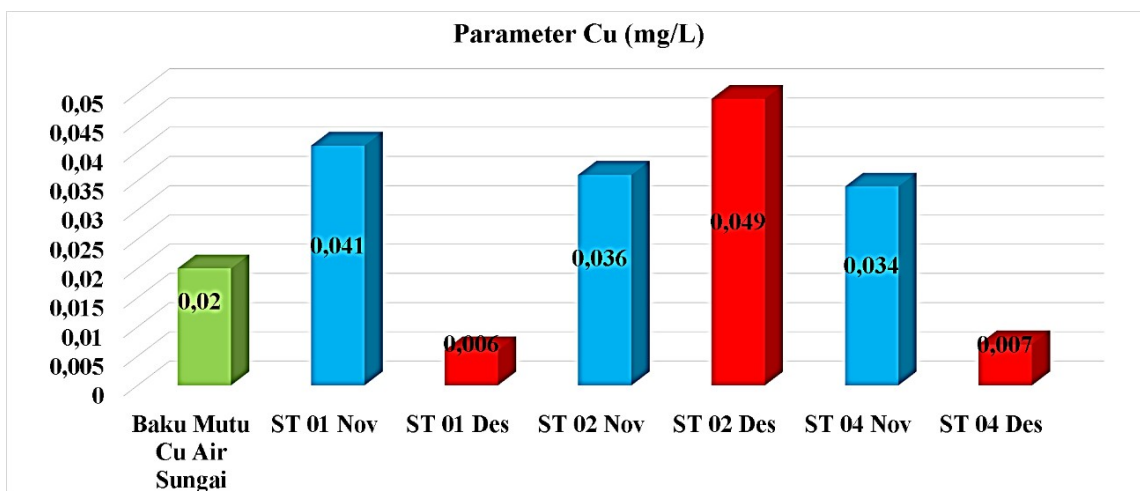
Figure 4. Concentration copper (Cu).

In Figure 4 it can be seen that the Copper value in November for both ST 01, ST 02, and ST 04 exceeded the quality standard, with values of 0.041 mg/L, 0.036 mg/L, and 0.034 mg/L. At the same time, the highest Copper value that exceeded the quality standard in December was ST 02 at 0.049 mg/L, whereas the Copper Quality Standard set based on PP 22 of 2021 is 0.02 mg/L.

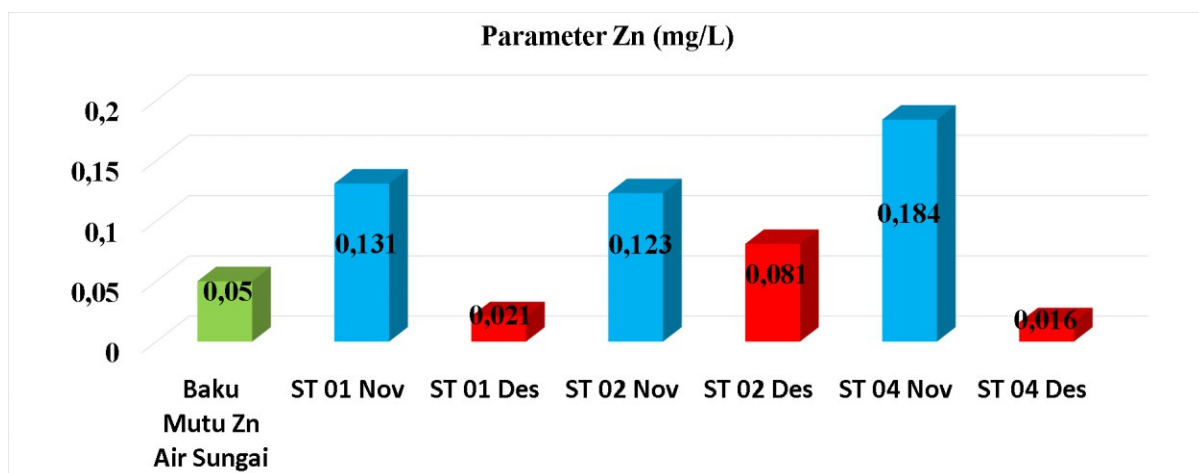
Figure 5. Zinc (Zn) concentration.

In Figure 5 it can be seen that the Zinc value in November at ST 01, ST 02, and ST 04 exceeded the Zinc quality standard for river water with values of 0.131 mg/L, 0.123 mg/L, and 0.184 mg/L. At the same time, the highest Zinc value in December was ST 02 at 0.081 mg/L with the quality standard set based on PP 82 of 2001 for a Zinc value of 0.05 mg/L.

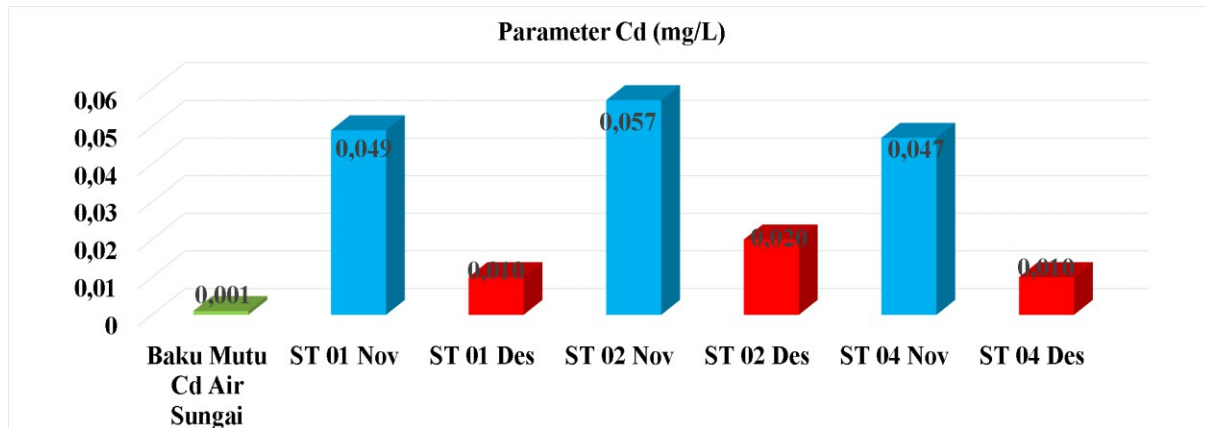
Figure 6. Cadmium (Cd) concentration.

In Figure 6 it can be seen that the Cadmium values in November and December at all sampling stations and/or research sampling points exceeded the Cadmium quality standard in river water. The highest Cadmium value in November was at ST 02 of 0.057 mg/L and the highest Cadmium value in December was at ST 02 of 0.020 mg/L.

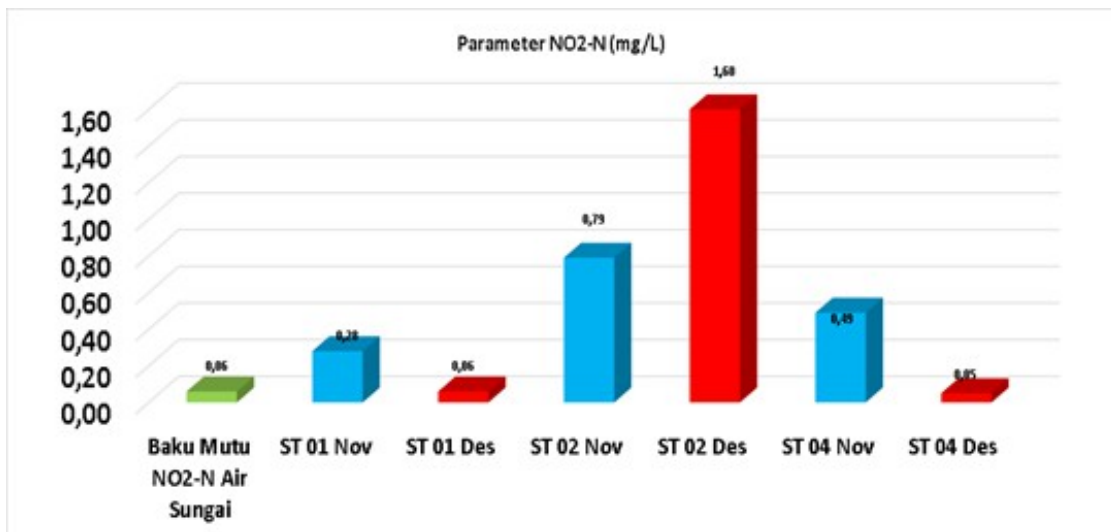
Figure 7. Nitrate ( $\text{NO}_2\text{-N}$ ) concentration.

The results of Nitrate analysis at ST 01 in November obtained a level of 0.28 mg/L and for ST 01 in December obtained a value of 0.06 mg/L, at ST 02 in November and December obtained Nitrate values of 0.79 and 1.60 mg/L as well as at point ST 04 with Nitrate values in November and December of 0.49 and 0.05 mg/L with a Quality Standard value of 0.06 mg/L.

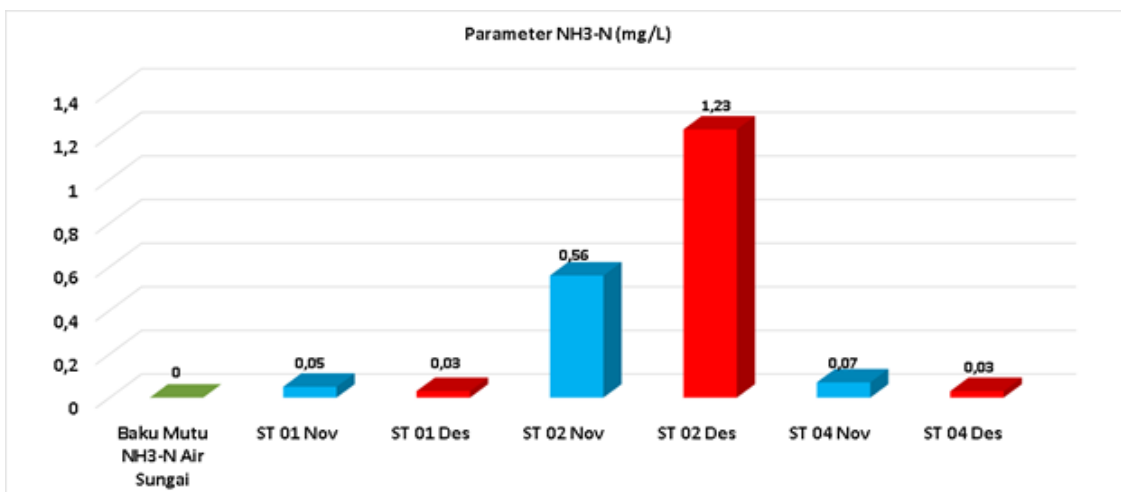
Figure 8. Ammonia ( $\text{NH}_3\text{-N}$ ) concentration.

In Figure 8 it can be seen that the amount of Ammonia value at the ST 1 research location in November and December obtained Ammonia values of 0.05 mg/L and 0.03 mg/L, for ST2 obtained Ammonia values in November and December 0.56 and 1.29 mg/L and at the ST 04 location obtained values of 0.07 mg/L in November and 0.03 mg/L in December. The quality standard of river water quality in PP 82 of 2001 Ammonia value in class I is 0.5 mg/L and for classes II, III, and IV is not regulated.

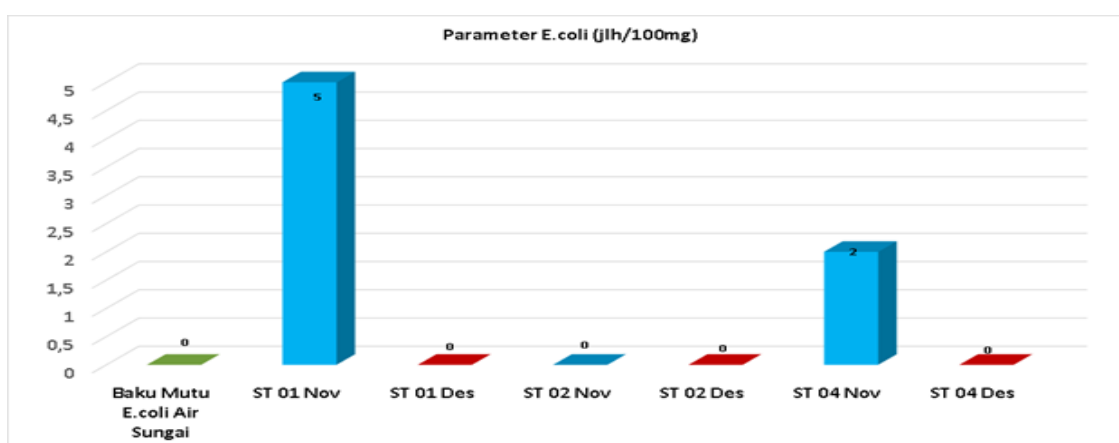
Figure 9. E.Coli concentration.

Figure 9 based on the results of the analysis it can be seen that the highest E.Coli value is at ST 01 in November obtained a value of 5 counts/100 ml and at ST 4 in November obtained a value of 2 counts/100 ml, for quality standards the value of E.Coli in PP 82 of 2001 is not regulated.
